**2017 Mission Hills Open Channel
Masterplan Update
Final Report**
Prepared for the City of Mission Hills, Kansas
October 20, 2017

Subject: Mission Hills 2017 Open Channel Masterplan Update

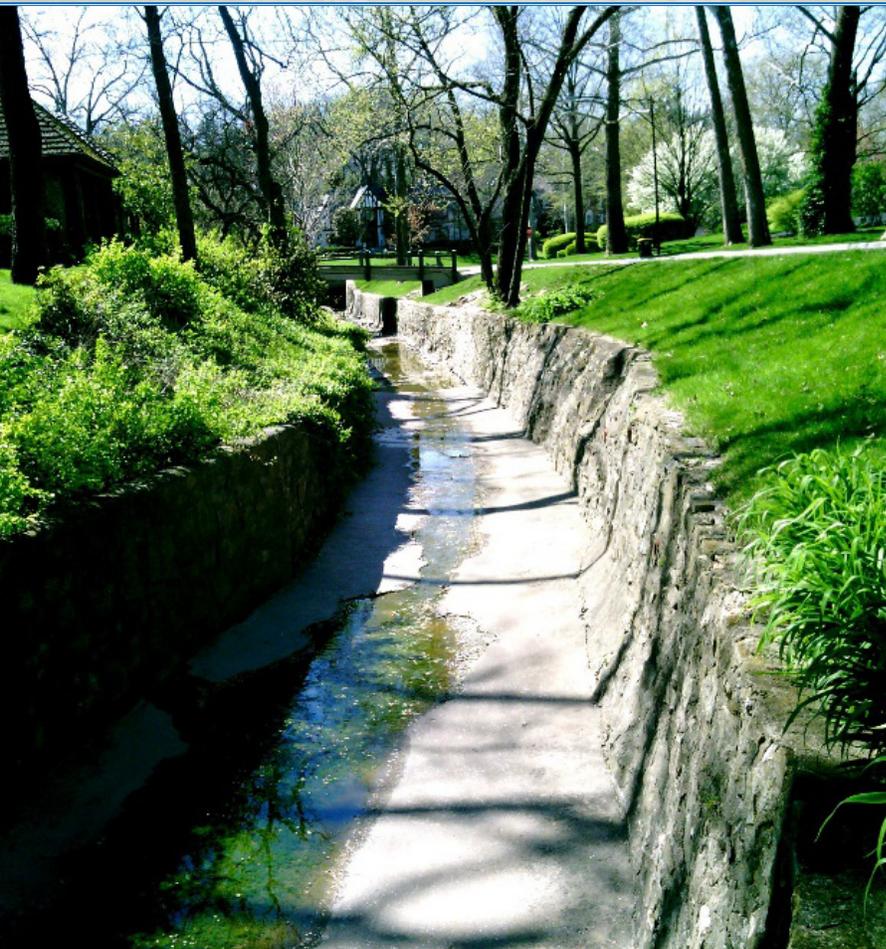
In general, the CCSM rating is negatively impacted due to steep bank slopes and the lack of sinuosity and pool-riffle structure. Most reaches have a low score on these three indicators. Lack of vegetative protection also has a negative impact on the stability rating. Most of the main channel widths are less than those found in stable natural channels. The lo-

as the concrete and walls provide the required protection. Concrete lined channels can become unstable over time if the concrete is eroded by the abrasive action of high velocity flows. If not maintained, once the concrete lining on the bed is lost, streambed degradation will progress at a rapid pace, and the wall foundations will be compromised. Without the concrete and the walls, the stream will be extremely unstable, especially if no vegetative protection exists on the banks.

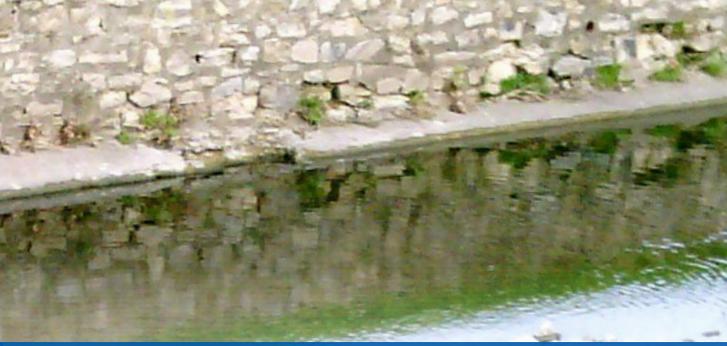
The most stable channels include the ones lined with grouted stone walls and a concrete bed. Figure 2 is a photo of one of the many concrete lined channels in Mission Hills. These channels, however, do not have a higher rating, because the banks are stable as long

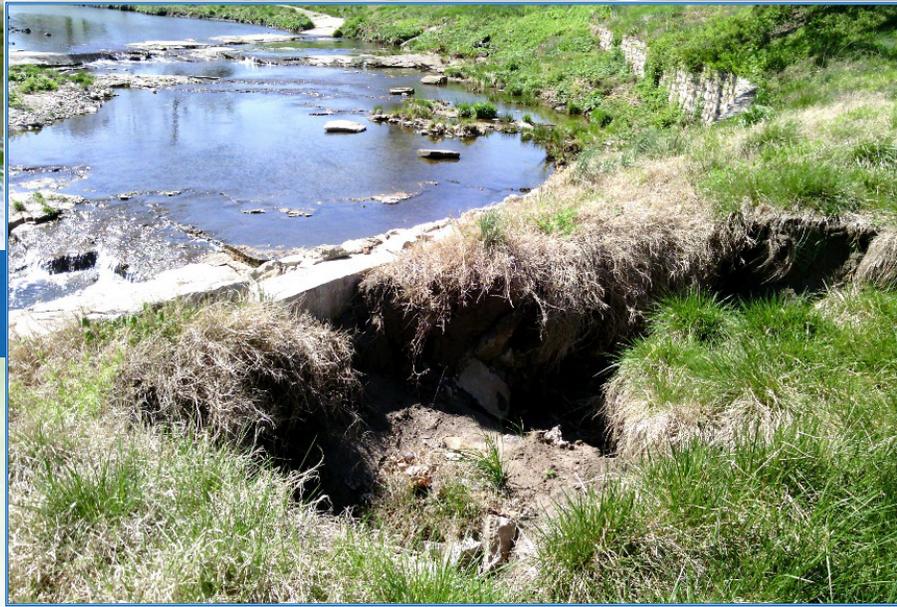
There were six gabion wall segments identified during the evaluation, and all were rated in fair condition. Also, 11 locations were noted identifying individual wall issues, including wall failures and erosion behind the walls. Figure 3 is a photo of one of the locations where there is major erosion behind a retaining wall. The locations and condition of each wall segment are illustrated on the Retaining Wall Conditions Map in Appendix A of this report.

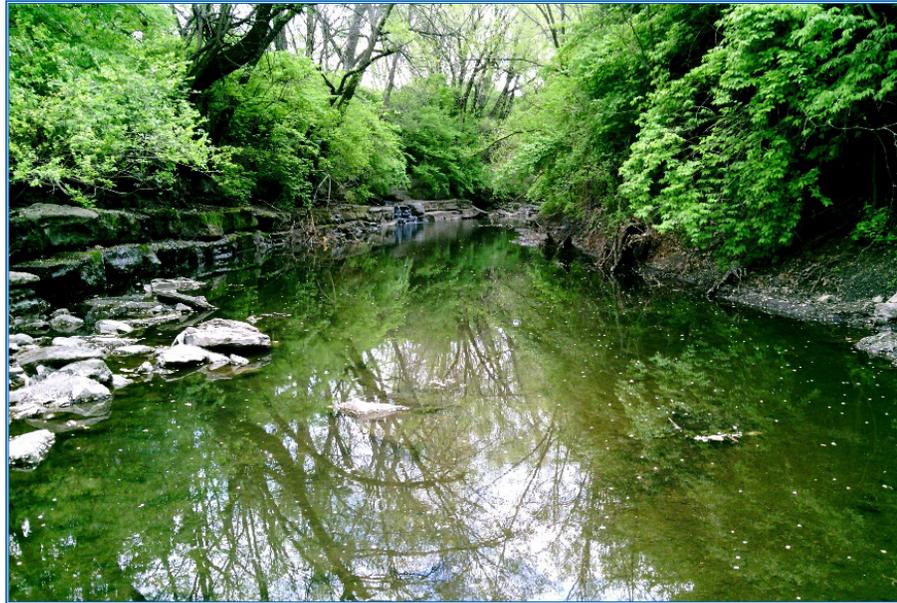
The locations and condition of the stream buffers are illustrated on the Stream Buffer Conditions Map in Appendix A of this report. Figure 4 is an example of an “Excellent” rated buffer, Figure 5 is an example of a “None” rated buffer.

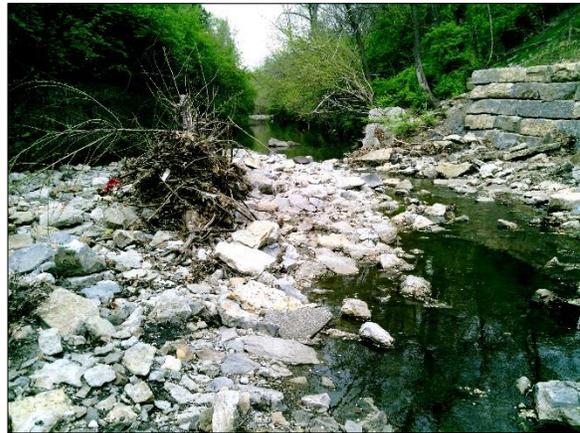
Stream Buffers: The stream buffer condition is “Good” at 5 to 15 feet wide on both banks. The stream buffer generally consists of large trees and smaller understory trees.

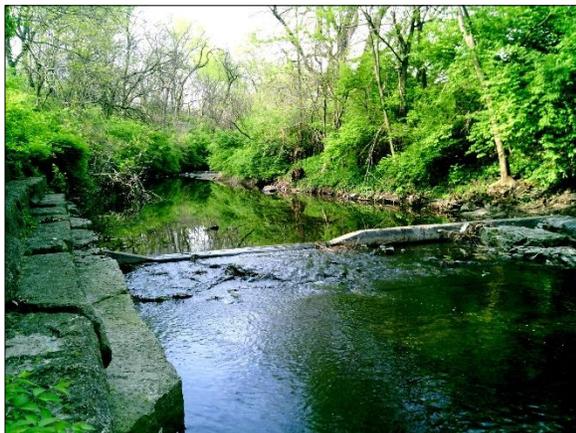
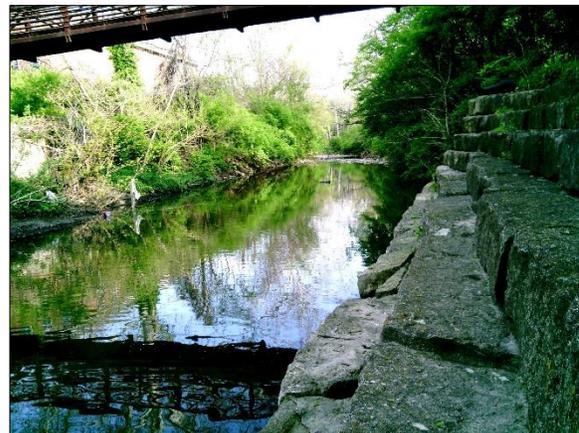
Stream Buffers: The stream buffer condition is “Good” at 5 to 15 feet wide on the left descending bank and “Excellent” at greater than 15 feet wide on the right descending bank. The stream buffer generally consists of large trees and smaller understory trees.

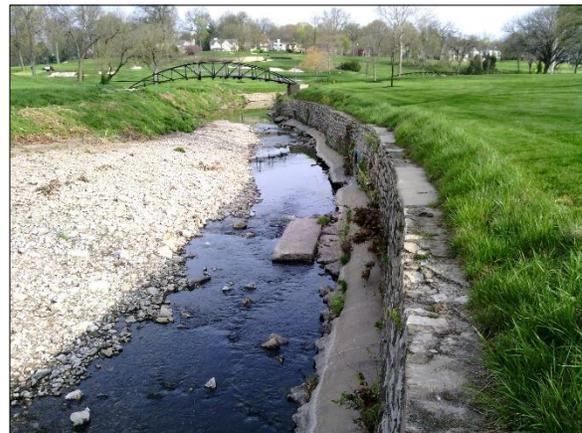
Stream Buffers: The stream buffer condition is “Good” at 5 to 15 feet wide on the left descending bank up to the golf course Access Road. Downstream of the Access Road there is no stream buffer. The right descending bank stream buffer condition is “Good” except where the stream parallels Mission Drive and north of the Access Road where there is no stream buffer. The stream buffer generally consists of a strip of taller unmown grass within the golf course.

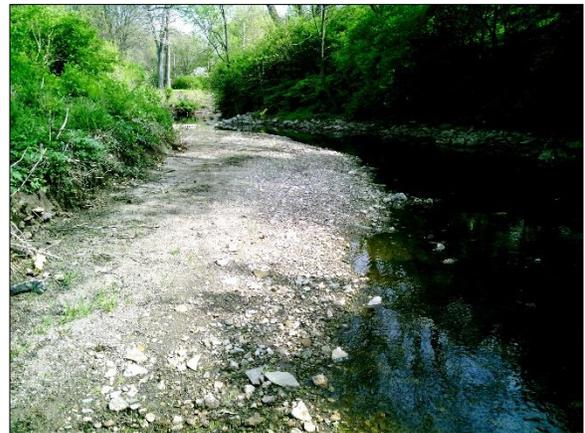
Stream Buffers: The stream buffer condition on the left descending bank ranges between no stream buffer where the stream is closer Indian Lane to “Good” as the stream moves away from Indian Lane. The stream buffer on the right descending bank ranges between “Fair” and “Excellent” moving downstream. The stream buffer generally consists of large trees and smaller understory trees.

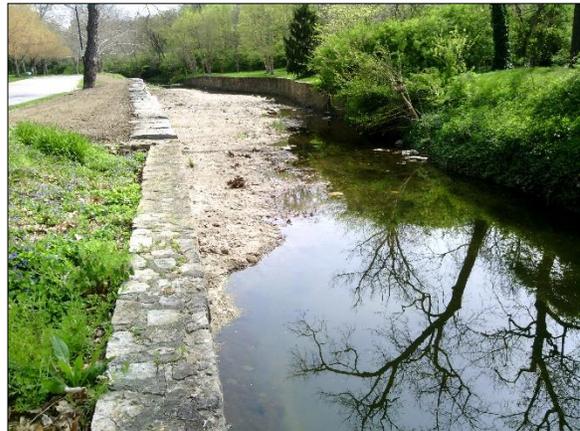
Stream Buffers: There is no stream buffer on a majority of the left descending bank because the stream is close to Indian Lane. A portion of the stream buffer is in “Good” condition where the stream moves away from Indian Lane. The stream buffer on the right descending bank ranges between “Good” and “Excellent”. The stream buffer generally consists of large trees and smaller understory trees.

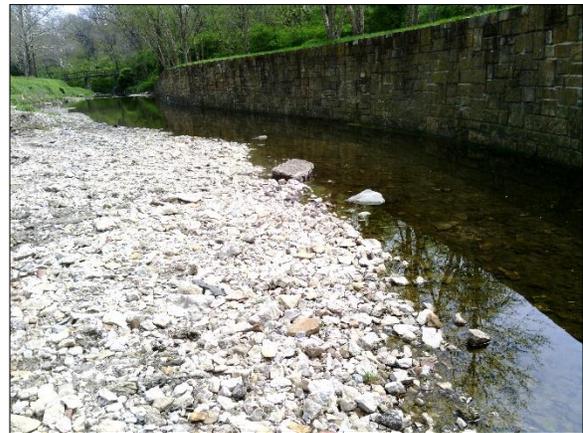
Stream Buffers: There is no stream buffer on the left descending bank because the stream is close to Indian Lane. The stream buffer on the right descending bank ranges between “None” to “Excellent”. The stream buffer generally consists of large trees and smaller understory trees.

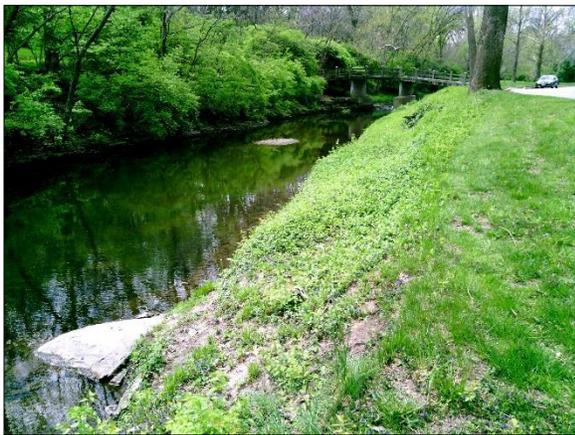
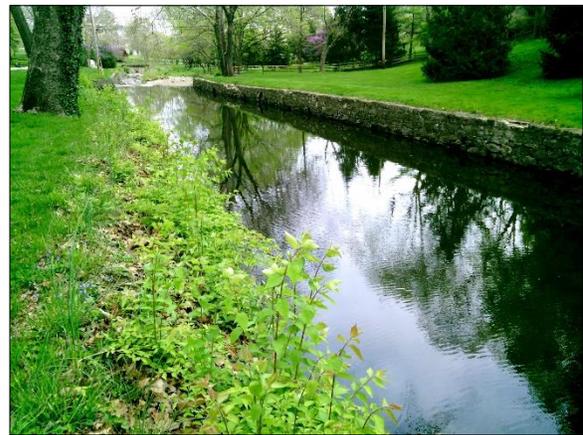
Stream Buffers: There is no stream buffer on the left descending bank because the stream is close to Indian Lane. The stream buffer on the right descending bank ranges is “Excellent” for the upstream half of the reach and “Acceptable” the downstream half. The stream buffer generally consists of large trees and smaller understory trees.

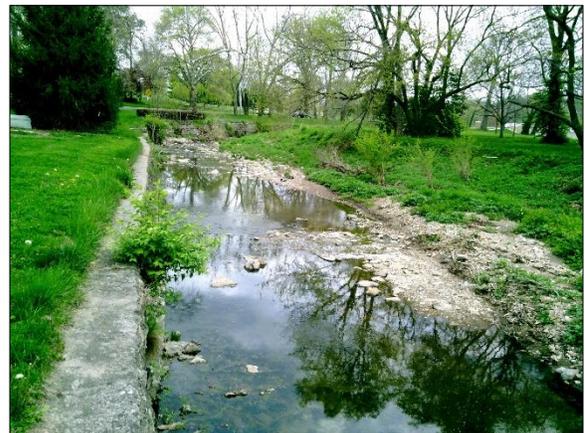
Stream Buffers: There is no stream buffer on the left descending bank because the stream is close to Indian Lane. The stream buffer on the right descending bank is “Acceptable” with a width of 1 to 5 feet. The stream buffer generally consists of large trees and smaller understory trees.

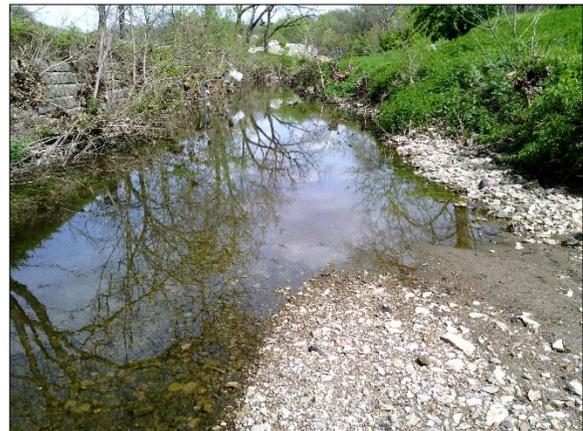
Stream Buffers: There is no stream buffer on the left descending bank upstream of the 63rd Street Bridge. Downstream of the bridge the stream buffer is “Good” with a width of 5 to 15 feet. The stream buffer generally consists of large trees and with unmown taller grass along the golf course.

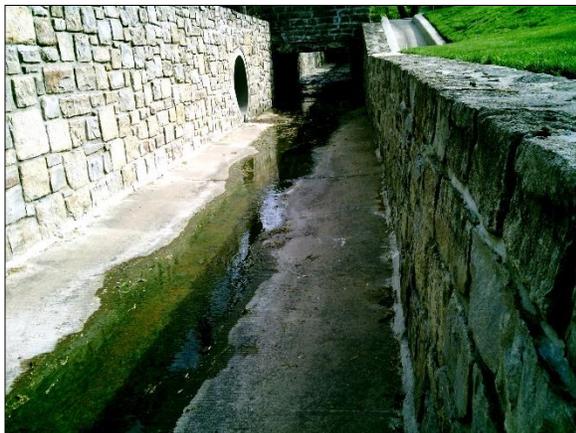
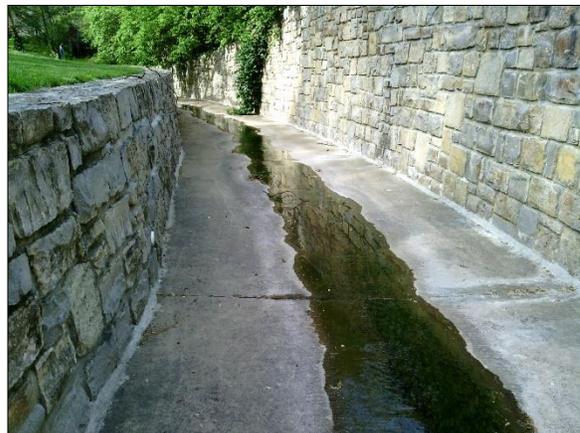
Stream Buffers: The stream buffers along this reach range between "None" and "Excellent" on both banks. The stream buffer generally consists of smaller trees and residentially landscaping at the top of the retaining walls.

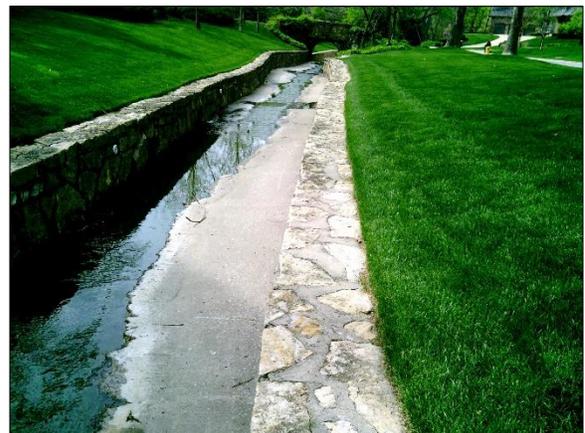
Stream Buffers: There is no stream buffer on the right descending bank. The stream buffer on the left descending bank is "Good" except for 150 feet upstream of the Seneca Road culvert, where there is no stream buffer. The stream buffer generally consists of smaller trees and residentially landscaping at the top of the retaining walls.

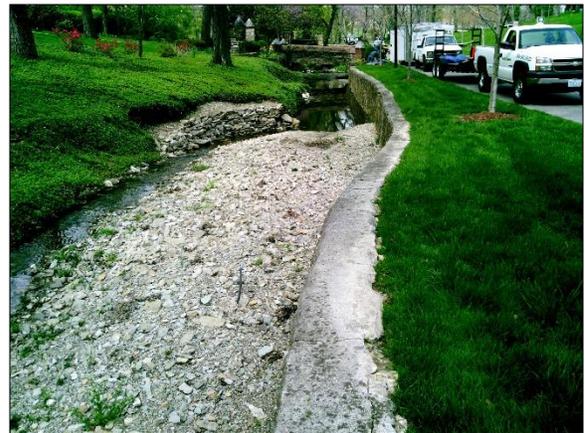
Stream Buffers: There is no stream buffer on the right descending bank with Wenonga Road at the top of bank. The stream buffer on the left descending bank is “Excellent” with a width greater than 15 feet. The stream buffer generally consists of large trees and smaller understory trees. In other areas, the stream buffer consists of large trees with landscaped ground cover.

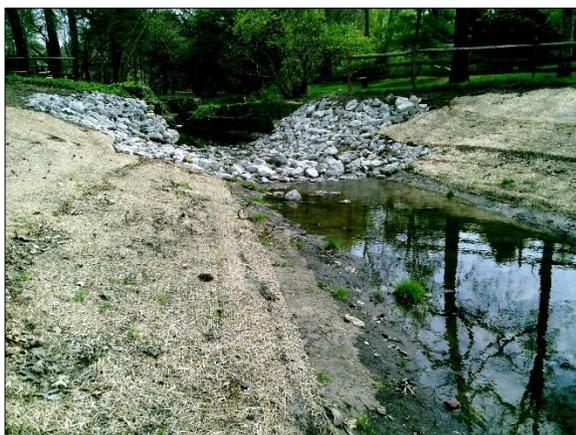
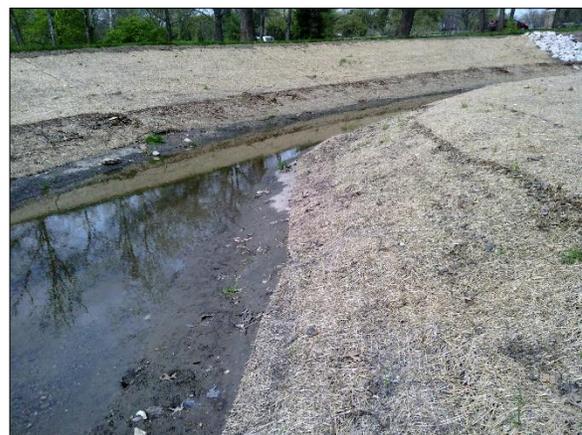
Stream Buffers: The stream buffer condition on both banks before entering Hiawassee Park are in “Good” condition. There is no stream buffer on either bank along the lower 300 feet of the reach because the vegetation from the Hiawassee Park Channel Improvement project had not been established yet. The stream buffer generally consists of large trees and smaller understory trees.

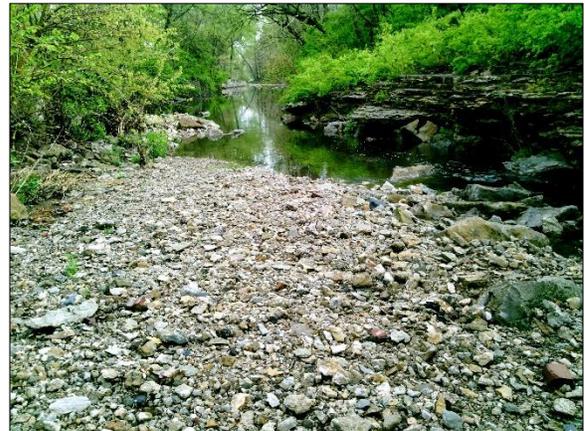
Stream Buffers: The stream buffer condition on the left descending bank is in “Good” condition, and the stream buffer on the right descending bank is in “Excellent” condition. The stream buffer generally consists of large trees and smaller understory trees.

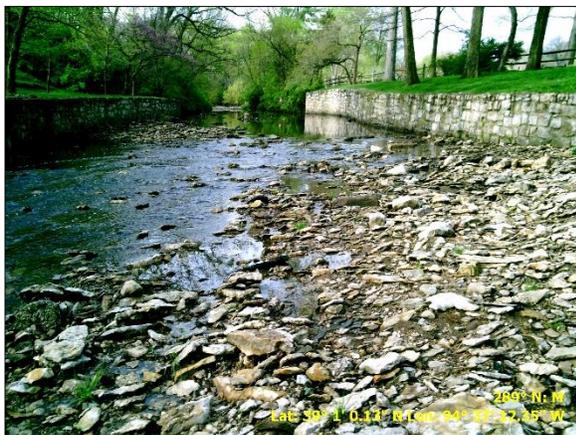
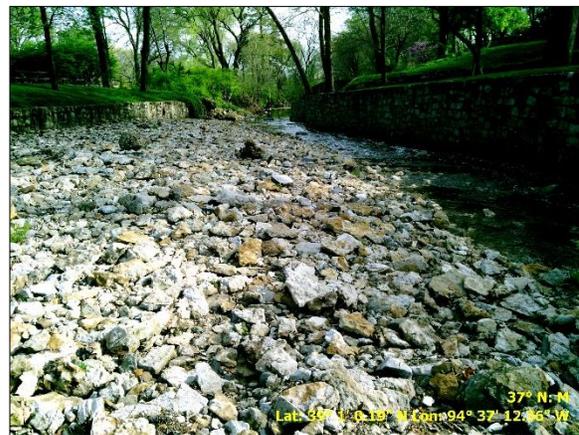
Stream Buffers: The stream buffer condition on the left descending bank is in “Good” condition, and the stream buffer on the right descending bank ranges between “Good” and “Excellent” with a 200-foot stretch of no stream buffer. The stream buffer generally consists of large trees and smaller understory trees.

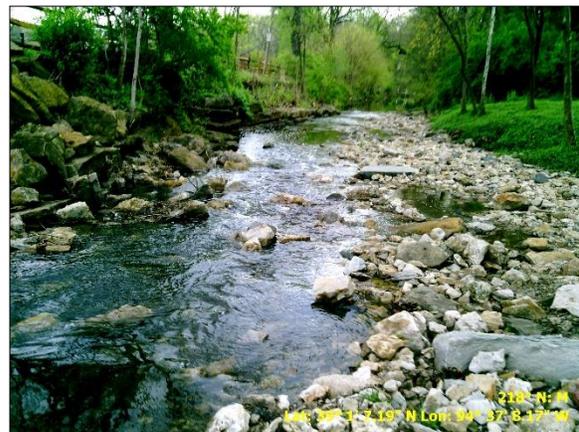
Stream Buffers: The stream buffer condition on the left descending bank is in “Good” condition for 150 feet then the stream buffer diminishes to “None”. The stream buffer on the right descending bank is “Excellent” the entire reach. The stream buffer generally consists of large trees and smaller understory trees.

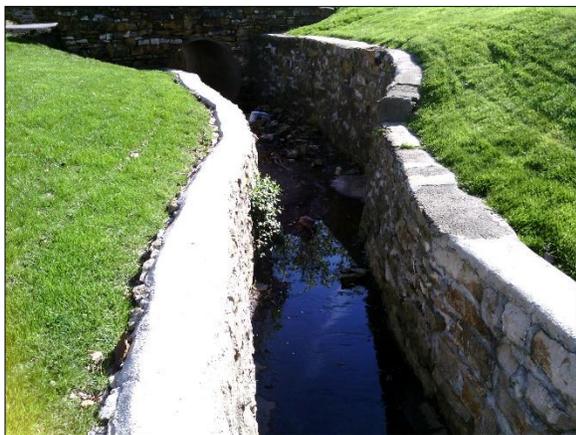
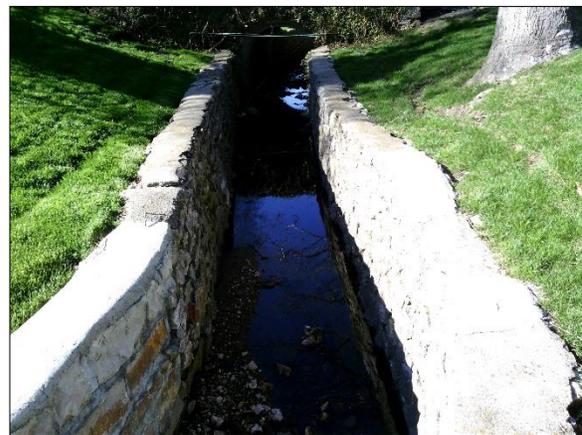
Stream Buffers: The stream buffers along this reach range between "None" and "Acceptable" on the left descending bank. There is no stream buffer on the right descending bank as it is very close to Willow Lane. The stream buffer generally consists of smaller trees and residentially landscaping at the top of the retaining walls.

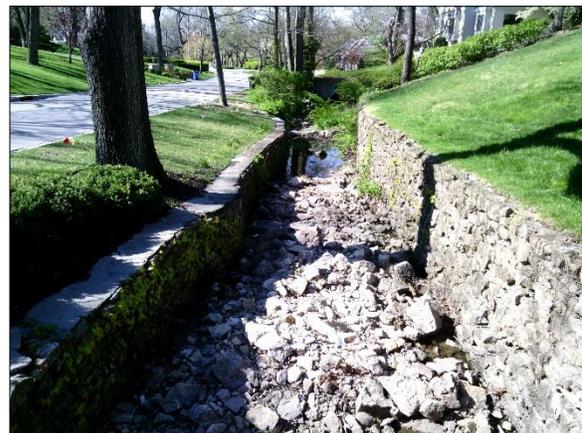
Stream Buffers: The stream buffers along this reach range between “None” and “Acceptable” on the left descending bank along Ensley Lane. The stream buffer on the right descending bank ranges between “None” and “Good”, with it being “Excellent” immediately downstream of Tomahawk Road. The stream buffer generally consists of smaller trees and residentially landscaping.

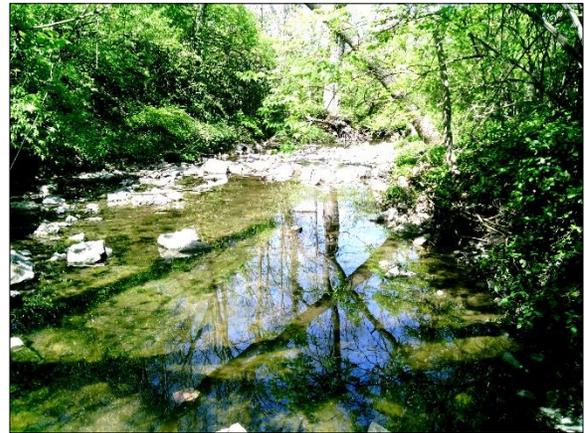
Stream Buffers: The stream buffer condition is “Excellent” at greater than 15 feet wide on the left descending bank and “Good” at 5 to 15 feet wide on the right descending bank. The stream buffer generally consists of large trees and smaller understory trees.

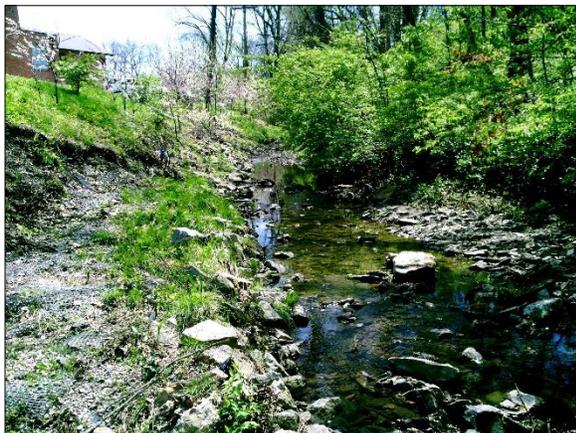
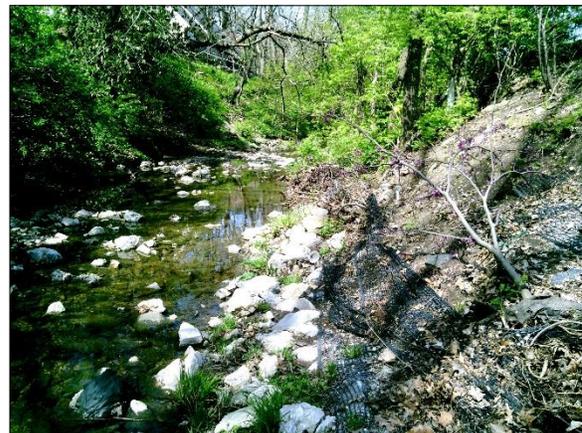
Stream Buffers: The stream buffer condition is “Excellent” at greater than 15 feet wide on the left descending bank and “Good” at 5 to 15 feet wide on the right descending bank. The stream buffer generally consists of large trees and smaller understory trees.

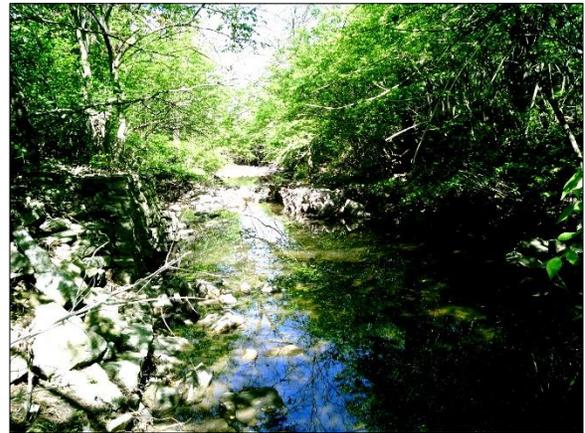
Stream Buffers: The stream buffer condition is “Excellent” at greater than 15 feet wide on both banks immediately downstream of the Tomahawk Road culvert and “Good” at 5 to 15 feet wide on both banks for the remainder of the reach. The stream buffer generally consists of large trees and smaller understory trees.

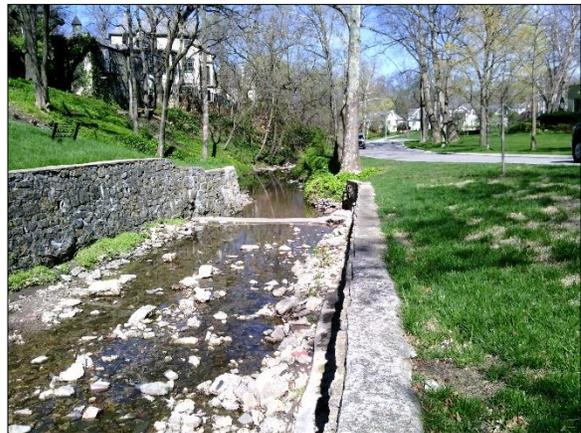
Stream Buffers: There is no stream buffer on the right descending bank as the channel is close to Mission Drive. The stream buffer on the left descending bank ranges from “Good” at 5 to 15 feet wide near W. 63rd Street to “Excellent” at greater than 15 feet approaching High Drive with a section of no stream buffer midway along the reach. The stream buffer generally consists of large trees and smaller understory trees and landscaping.

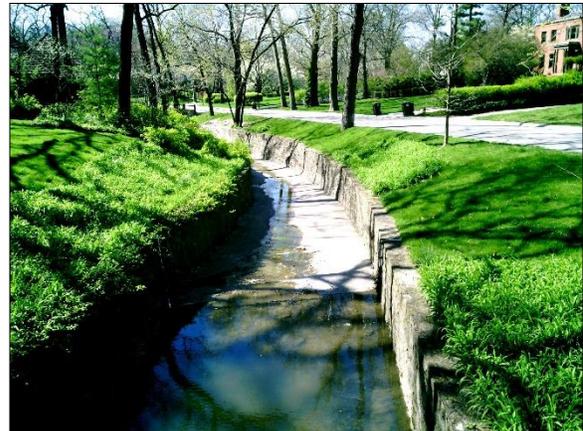
Stream Buffers: There is no stream buffer on the right descending bank as the channel is close to Mission Drive. The stream buffer on the left descending bank is “Excellent” at greater than 15 feet wide from High Drive to midway along the reach, then it is “Good” at 5 to 15 feet wide the remainder of the reach. The stream buffer generally consists of large trees and smaller understory trees and landscaping. The stream buffer generally consists of large trees and smaller understory trees and landscaping.

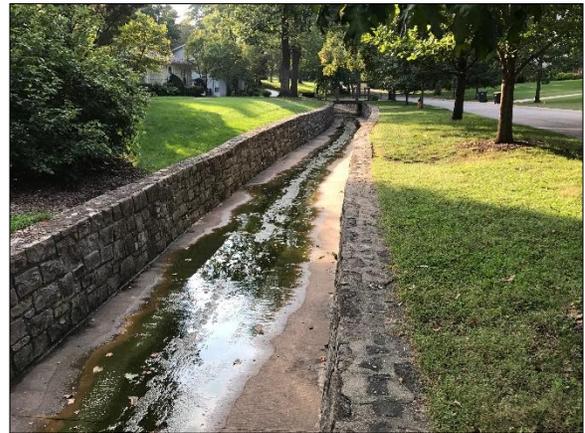
Stream Buffers: There is no stream buffer along this reach.
