**2017 Mission Hills Open Channel
Masterplan Update
Final Report**
Prepared for the City of Mission Hills, Kansas
October 20, 2017

Subject: Mission Hills 2017 Open Channel Masterplan Update

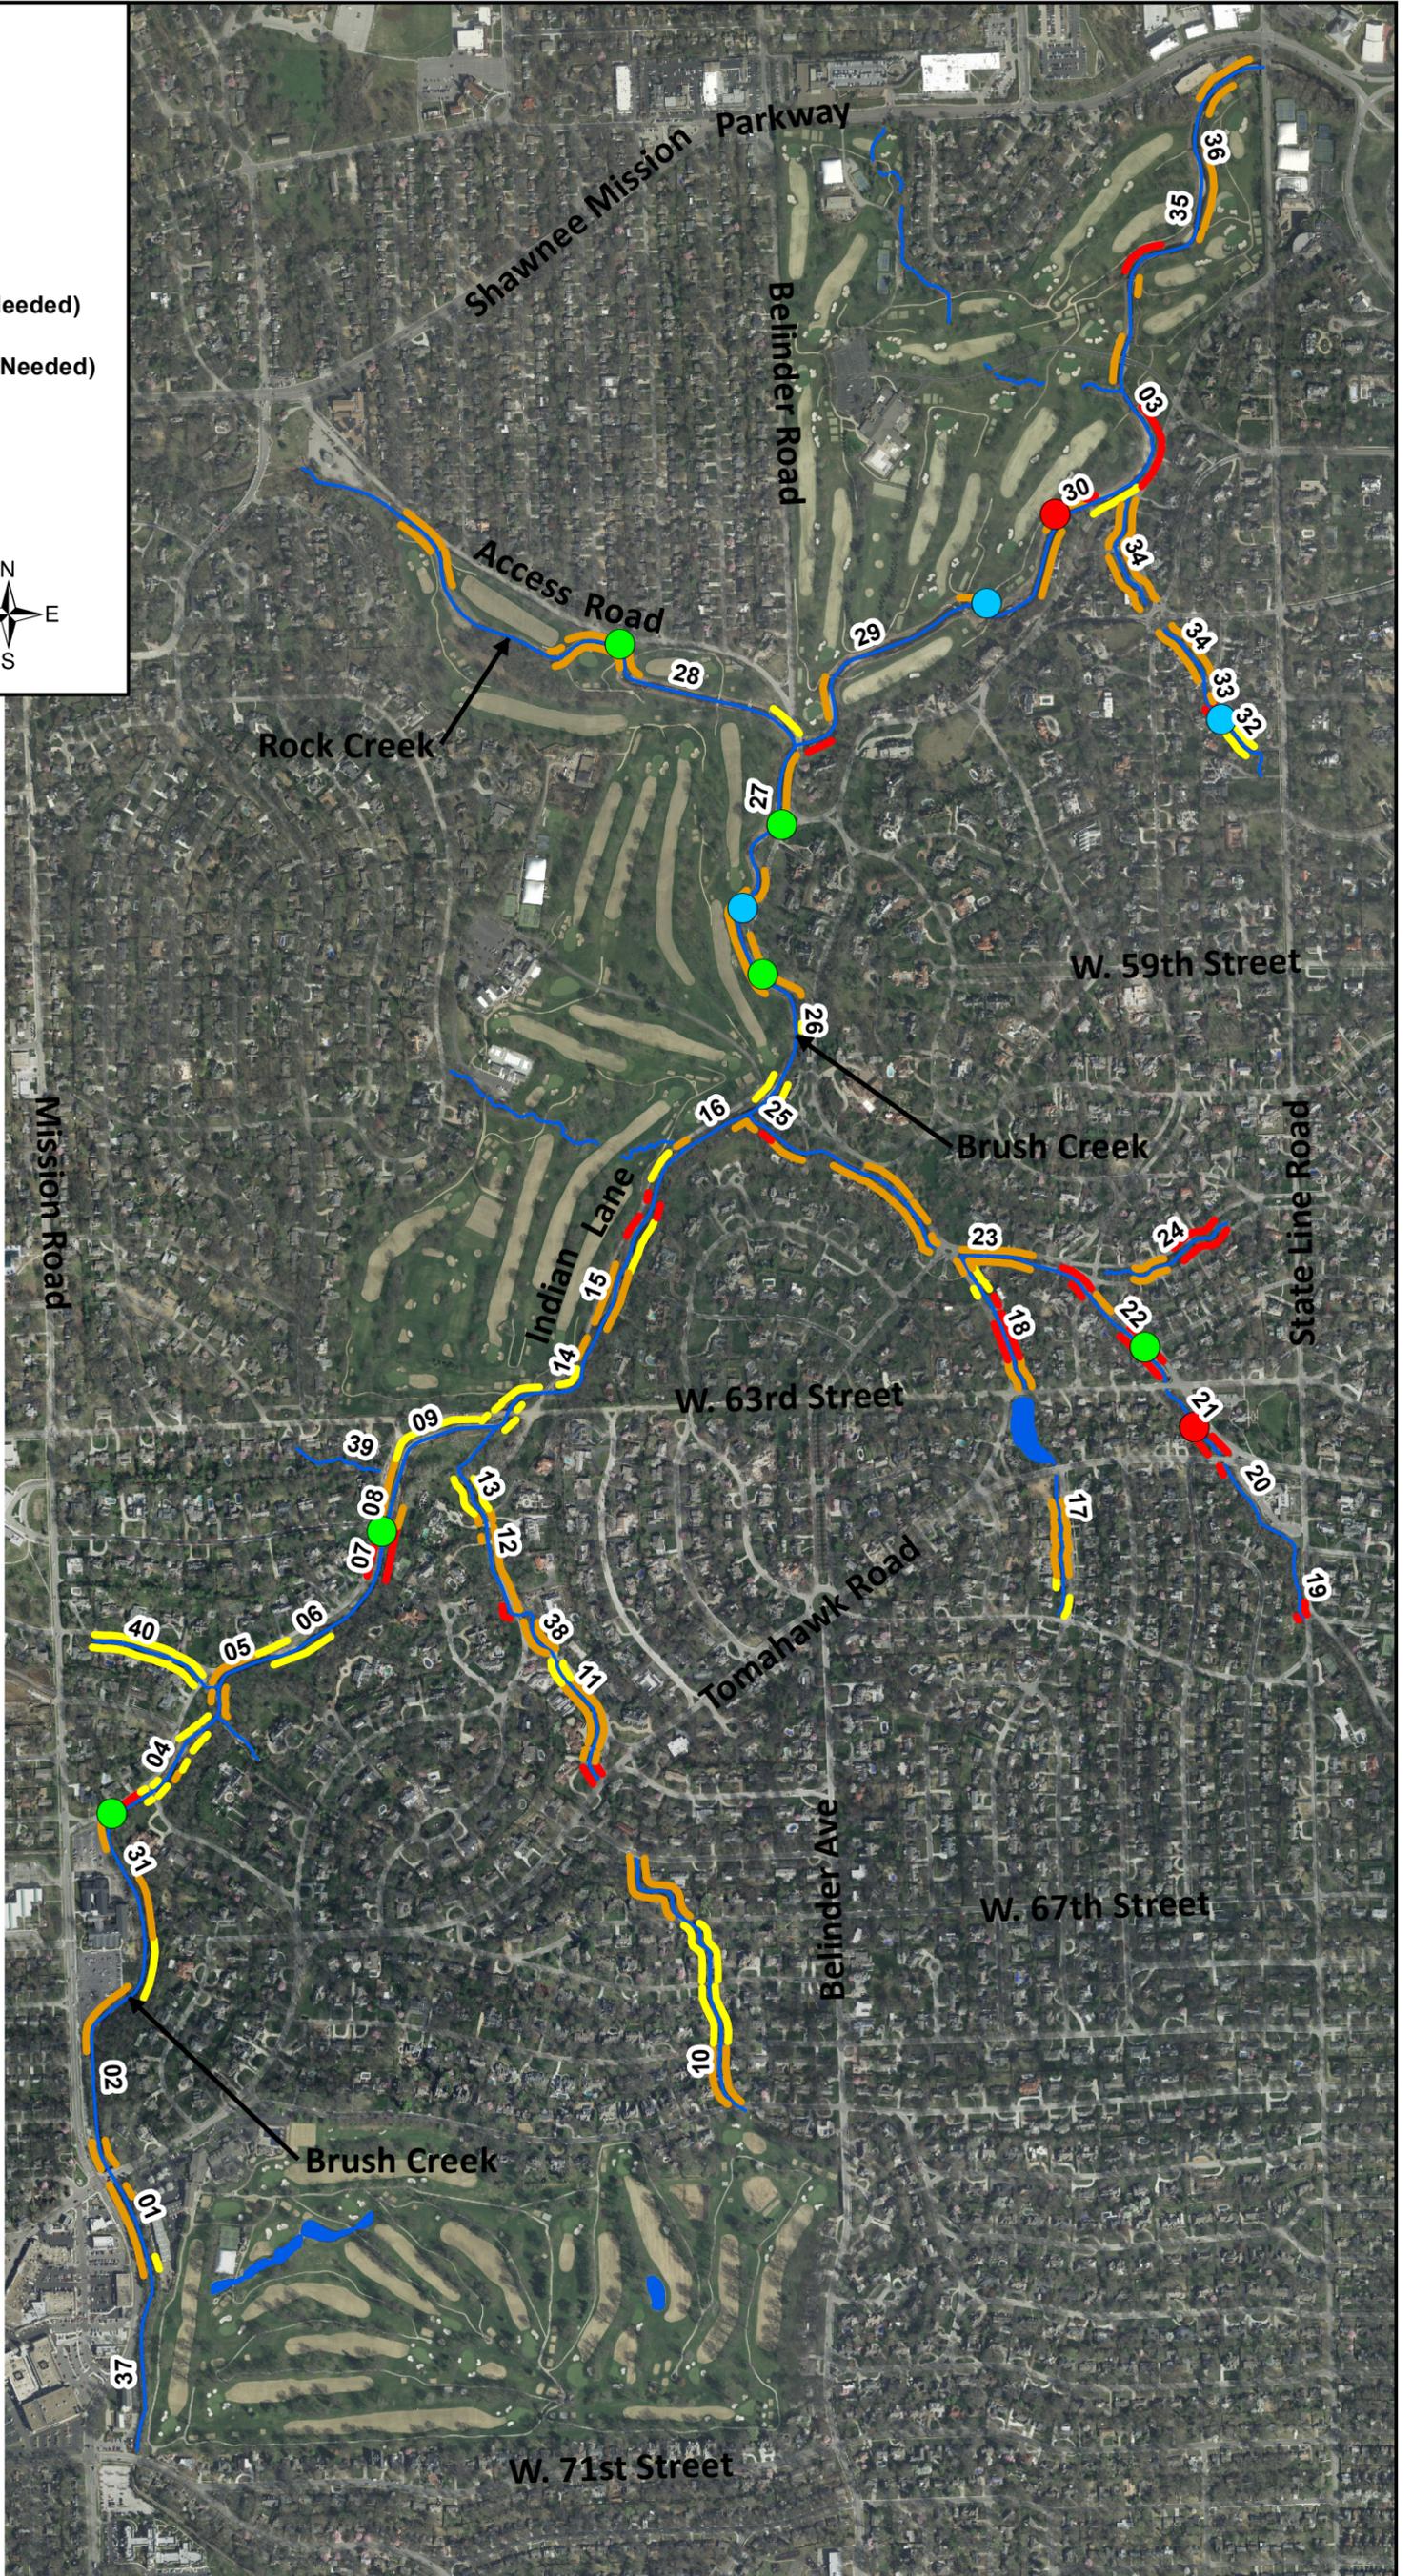
Retaining Wall Condition Map

- Wall failure
- Major erosion
- Minor erosion
- Good (No Repair Needed)
- Fair (Some Repair Needed)
- Poor (Failing)
- Open Channels

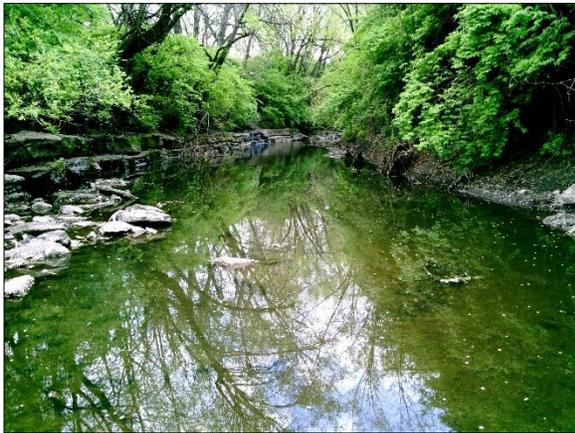
Reach 01 – Existing Conditions

Channel Condition Score: 18.2

Channel Condition Ranking: Fair

Channel Condition Description: This reach received “Poor” ratings for having bank angles greater than 60 degrees, a lack of sinuosity, and a large radius of curvature to channel width ratio. This reach received “Good” ratings for having well vegetated banks, little evidence of bank cutting and infrequent mass wasting.

Retaining Walls: There are a total of 489 feet of retaining wall on the left descending bank and 132 feet of retaining wall on the right descending bank. There are 390 feet of gabion retaining wall on the left descending bank. A 69-foot section of retaining wall on the right descending bank is in “Good” condition, and the rest of the retaining walls are in “Fair” condition with some repair needed.

Stream Buffers: The stream buffer condition is “Good” at 5 to 15 feet wide on both banks. The stream buffer generally consists of large trees and smaller understory trees.

Localized Improvements: The localized improvements for this reach include repairing/replacing the sections of retaining walls in “Fair” and “Poor” condition along the reach. Site restoration includes Streambank Planting and Sodding. Streambank Planting includes planting native vegetation along the stream bank above the repaired/replaced retaining walls to restore/improve the stream buffer where space is allowed. Sodding includes restoring all other areas disturbed by construction activity.

An estimated 226 feet of retaining wall will need to be replaced for along this reach and 310 square yards of stream planting and sodding.

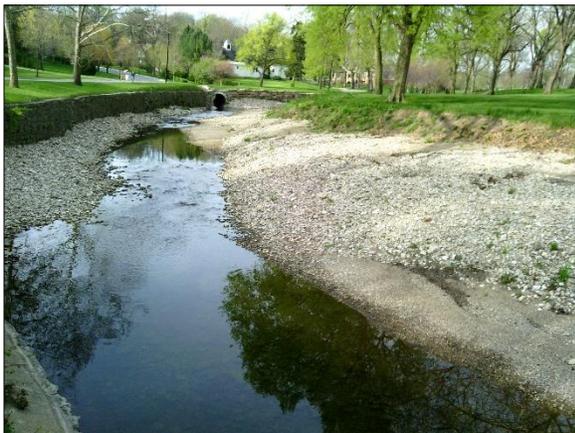
Reach 03 – Existing Conditions

Channel Condition Score: 20.8

Channel Condition Ranking: Poor

Channel Condition Description: This reach received “Poor” ratings for having a lack of sinuosity, steep bank slopes, lack of vegetative bank protection, and having a large radius of curvature to channel width ratio. This reach received “Fair” ratings for having average bank heights between six and 15 feet, significant and frequent bank cutting and mass wasting, and wide bar widths relative to the stream width. This reach was part of the Brush Creek, Belinder Avenue to East Mission Drive Project (2017) and also the Brush Creek Ramp Project (2013).

Retaining Walls: There are a total of 235 feet of retaining wall on the left descending bank and 596 feet of retaining wall on the right descending bank. The retaining wall on the left descending bank is in “Fair” condition. A 126-foot section of retaining wall on the right descending bank is in “Good” condition, which was replaced as part of the Brush Creek Ramp Project (2013), and the rest of the retaining walls are in “Poor” condition.

Stream Buffers: The stream buffer condition is “Good” at 5 to 15 feet wide on the left descending bank up to the golf course Access Road. Downstream of the Access Road there is no stream buffer. The right descending bank stream buffer condition is “Good” except where the stream parallels Mission Drive and north of the Access Road where there is no stream buffer. The stream buffer generally consists of a strip of taller unmown grass within the golf course.

Localized Improvements: The localized improvements for this reach include repairing/replacing the sections of retaining walls in “Fair” and “Poor” condition along the reach. Site restoration includes Streambank Planting and Sodding. Streambank Planting includes planting native vegetation along the stream bank above the repaired/replaced retaining walls to restore/improve the stream buffer where space is allowed. Sodding includes restoring all other areas disturbed by construction activity.

An estimated 587 feet of retaining wall will need to be replaced along this reach and 310 square yards of stream planting and 654 square yards of sodding.

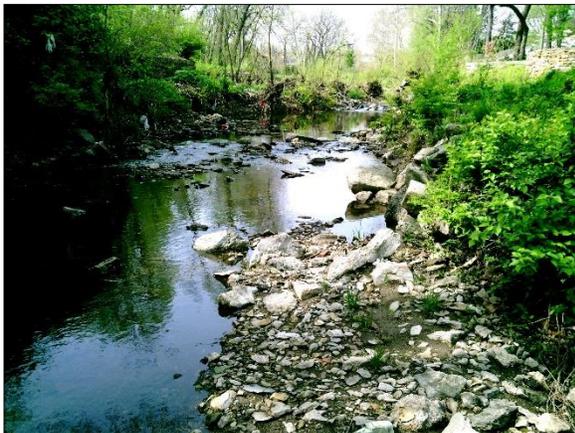
Reach 04 – Existing Conditions

Channel Condition Score: 17.4

Channel Condition Ranking: Fair

Channel Condition Description: This reach received “Poor” ratings for having a steep bank slopes, lack of vegetative bank protection, and having pool-riffle spacing to channel width ratio between 3 and 9. This reach received “Good” ratings for having little bank cutting and mass wasting and having a sinuosity between 1.2 and 1.4 and a radius of curvature to channel width ratio between 3 and 5. This section of Brush Creek was part of the Peetwood Park Stream Restoration Project (2009).

Retaining Walls: There are 10 sections of retaining wall totaling 181 feet on the left descending bank and 327 feet of retaining wall on the right descending bank. The retaining walls on the left descending bank are in “Good” condition. 105 feet of retaining wall on the right descending bank is in “Fair” condition with the rest in “Good” condition.

Stream Buffers: The stream buffer condition on the left descending bank ranges between no stream buffer where the stream is closer Indian Lane to “Good” as the stream moves away from Indian Lane. The stream buffer on the right descending bank ranges between “Fair” and “Excellent” moving downstream. The stream buffer generally consists of large trees and smaller understory trees.

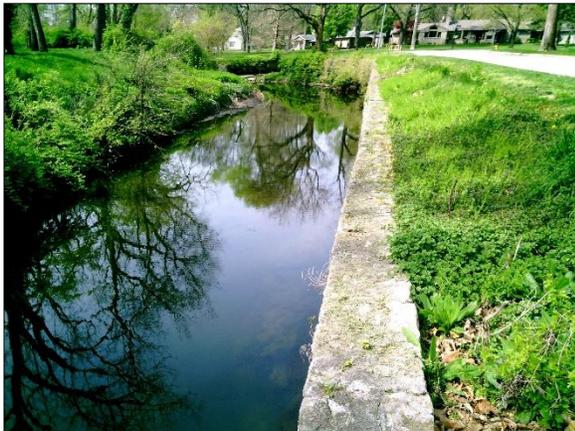
Reach 05 – Existing Conditions

Retaining Walls: There are a total of 385 feet of retaining wall on the left descending bank and 78 feet of retaining wall on the right descending bank. A 53-foot section of retaining wall on the left descending bank is in “Good” condition, and the rest of the left descending bank retaining walls are in “Fair” condition with some repair needed. The retaining walls on the right descending bank in “Fair” condition.

Stream Buffers: There is no stream buffer on a majority of the left descending bank because the stream is close to Indian Lane. A portion of the stream buffer is in “Good” condition where the stream moves away from Indian Lane. The stream buffer on the right descending bank ranges between “Good” and “Excellent”. The stream buffer generally consists of large trees and smaller understory trees.

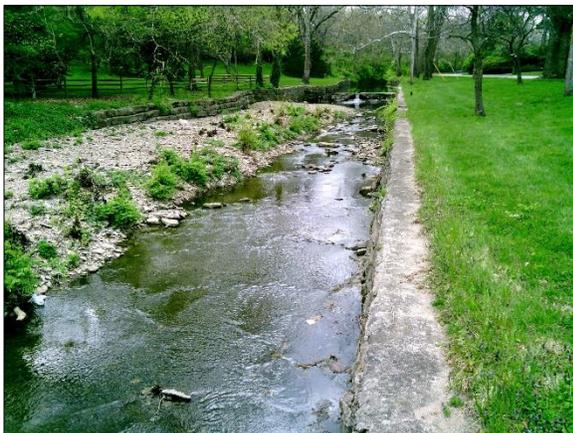
Retaining Walls: There are a total of 316 feet of retaining wall on the left descending bank and 96 feet of retaining wall on the right descending bank. All the retaining wall in this reach are in “Fair” condition needing some repair.

Stream Buffers: There is no stream buffer on the left descending bank because the stream is close to Indian Lane. The stream buffer on the right descending bank is “Acceptable” with a width of 1 to 5 feet. The stream buffer generally consists of large trees and smaller understory trees.

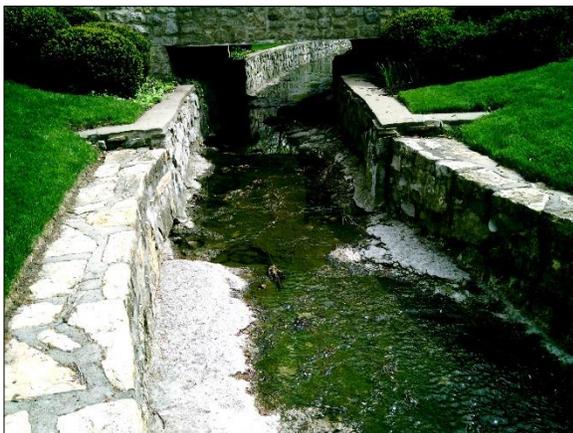
Retaining Walls: There are a total of 642 feet of retaining wall on the left descending bank and 590 feet of retaining wall on the right descending bank. The retaining walls on both banks immediately downstream of the Tomahawk Road culvert are in "Poor" condition, and the retaining walls on both banks immediately upstream of the Seneca Road culvert are in "Good" condition. The rest of the retaining walls on both banks are in "Fair" condition in need of some repair.

Stream Buffers: There is no stream buffer on the right descending bank. The stream buffer on the left descending bank is "Good" except for 150 feet upstream of the Seneca Road culvert, where there is no stream buffer. The stream buffer generally consists of smaller trees and residentially landscaping at the top of the retaining walls.

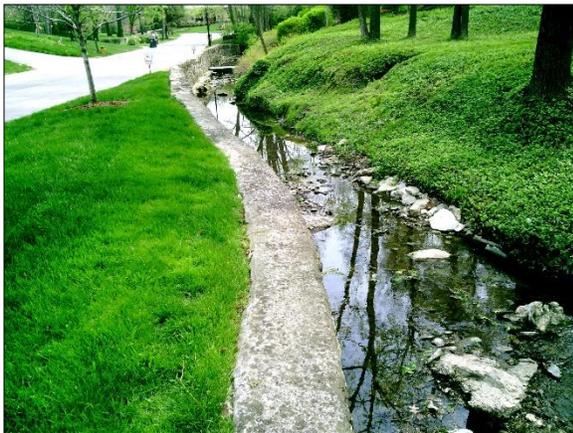
Retaining Walls: There is a small 24-foot section of retaining wall on the left descending bank. Retaining walls line the right descending bank for the entire length of the project reach totaling 430 feet. All the retaining walls along this reach are in “Fair” condition needing some repair.

Stream Buffers: There is no stream buffer on the right descending bank with Wenonga Road at the top of bank. The stream buffer on the left descending bank is “Excellent” with a width greater than 15 feet. The stream buffer generally consists of large trees and smaller understory trees. In other areas, the stream buffer consists of large trees with landscaped ground cover.

- Replace bridge on Wenonga Road. Bridge abutments are in poor condition and may be structurally unstable.
- Match proposed cross-section. Create flood benches (see figure below).
- Repair or replace right bank walls. Add walls on the left bank for slope stability.
- Because meandering would be difficult to attain in this reach, a stepped channel is recommended as an alternative to a meandering channel. Preliminary calculations indicate that 7 12-in drops, spaced every 86 ft can be built to produce the stepped channel.
- Replace two driveway bridges to accommodate new channel.

- Vegetate banks and create buffer zone.

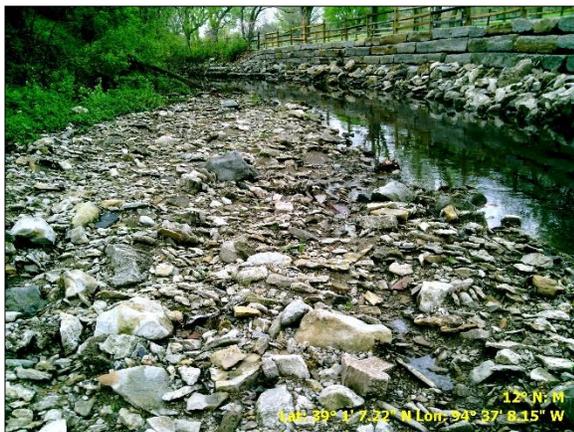
Channel Condition Description: This reach received “Poor” ratings for having a lack of sinuosity and having a large radius of curvature to channel width ratio. This reach received “Good” ratings for having average bank heights less than 6 feet, showing little evidence of mass wasting, and having small amounts of debris in the channel. This reach was part of the Brush Creek 63rd Street to Kansas City Country Club (KCCC) Low-Water Crossing Project (2015). A section of this reach was part of the Brush Creek Bank Stabilization Project (2012).

Retaining Walls: There are five sections of retaining wall along this reach. A total of 264 feet of retaining wall on the left descending bank and 129 feet on the right descending bank. 40 feet of retaining wall on the left descending bank is in “Poor” condition and 62 feet in “Fair” condition. The rest of the left descending bank retaining wall is in “Good” condition. There is 68 feet of retaining wall on the right descending bank in “Poor” condition and 61 feet in “Fair” condition. The rest of the retaining walls are in “Good” condition.

Stream Buffers: The stream buffer condition on the left descending bank is in “Good” condition for 150 feet then the stream buffer diminishes to “None”. The stream buffer on the right descending bank is “Excellent” the entire reach. The stream buffer generally consists of large trees and smaller understory trees.

Localized Improvements: The localized improvements for this reach include repairing/replacing the sections of retaining walls in “Fair” and “Poor” condition along the reach. Site restoration includes Streambank Planting and Sodding. Streambank Planting includes planting native vegetation along the stream bank above the repaired/replaced retaining walls to restore/improve the stream buffer where space is allowed. Sodding includes restoring all other areas disturbed by construction activity. Streambank reshaping is also included.

An estimated 120 feet of retaining wall will need to be replaced along this reach and 65 square yards of streambank planting and 80 square yards of sodding associated with the retaining wall.

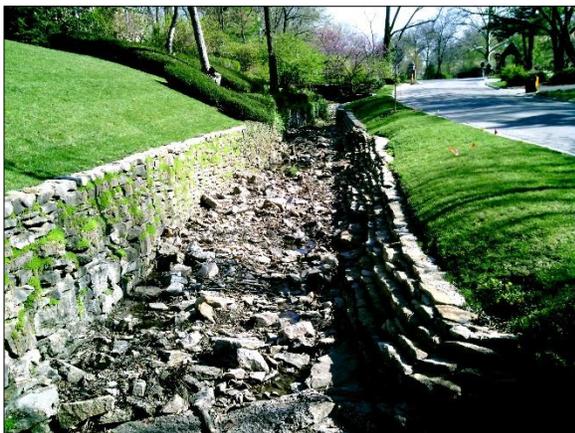
Retaining Walls: There are a total of 472 feet of retaining wall on the left descending bank and 633 feet of retaining wall on the right descending bank. The retaining walls on both banks at the beginning of the reach just downstream of Tomahawk Road are in “Fair” condition. There is 200 feet of retaining wall on the left descending bank in “Poor” condition and 44 feet in “Good” condition. There is 295 feet of retaining wall on the right descending bank in “Poor” condition. The retaining wall approaching Mission Drive is in “Fair” condition.

Stream Buffers: The stream buffers along this reach range between “None” and “Acceptable” on the left descending bank along Ensley Lane. The stream buffer on the right descending bank ranges between “None” and “Good”, with it being “Excellent” immediately downstream of Tomahawk Road. The stream buffer generally consists of smaller trees and residentially landscaping.

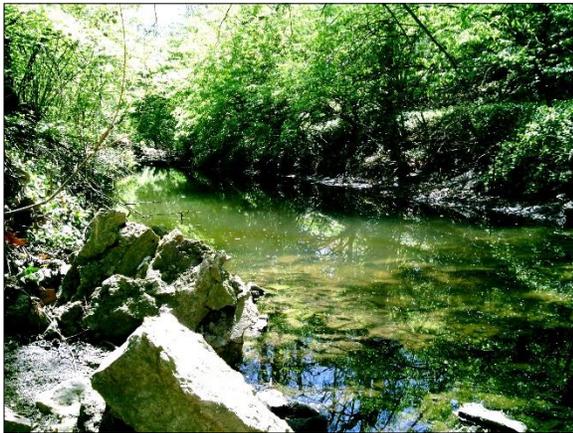
Retaining Walls: The only retaining walls along the reach are located on both banks immediately downstream of State Line Road totaling 88 feet. All retaining wall are in “Poor” condition.

Stream Buffers: The stream buffer condition is “Excellent” at greater than 15 feet wide on the left descending bank and “Good” at 5 to 15 feet wide on the right descending bank. The stream buffer generally consists of large trees and smaller understory trees.

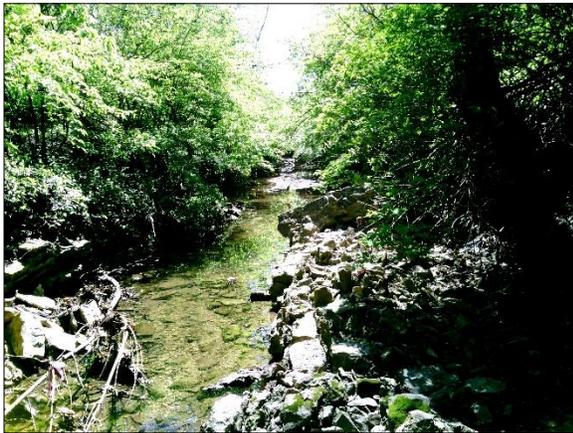
Retaining Walls: The only retaining wall along the reach are located on both banks just downstream of the Tomahawk Road culvert, and they are in “Poor” condition.

Stream Buffers: The stream buffer condition is “Excellent” at greater than 15 feet wide on both banks immediately downstream of the Tomahawk Road culvert and “Good” at 5 to 15 feet wide on both banks for the remainder of the reach. The stream buffer generally consists of large trees and smaller understory trees.

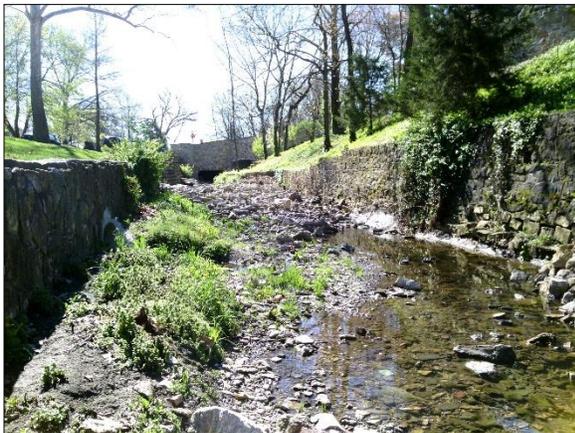
Retaining Walls: There is 292 feet of retaining wall on the left descending bank and 360 feet on the right descending bank. All the retaining wall on the left descending bank is in “Poor” condition, and 245 feet is in “Poor” condition on the right descending bank. 115 feet of retaining wall is in “Fair” condition on the right descending bank.

Stream Buffers: There is no stream buffer on the right descending bank as the channel is close to Mission Drive. The stream buffer on the left descending bank ranges from “Good” at 5 to 15 feet wide near W. 63rd Street to “Excellent” at greater than 15 feet approaching High Drive with a section of no stream buffer midway along the reach. The stream buffer generally consists of large trees and smaller understory trees and landscaping.

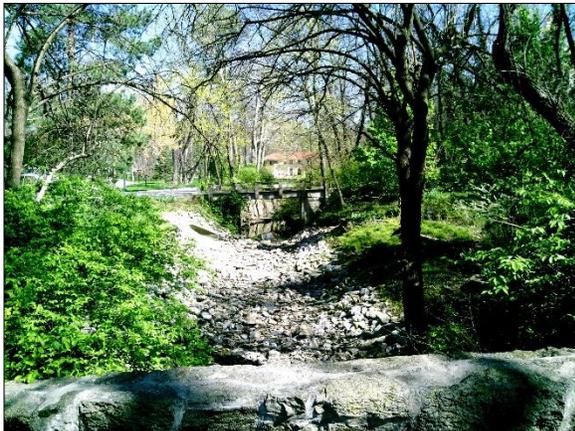
Retaining Walls: There is 435 feet of retaining wall on the left descending bank and 543 feet on the right descending bank. The retaining walls on both banks just downstream of High Drive are in “Poor” condition, and the retaining walls on both banks approaching the culvert under the intersection of Ensley Lane and Mission Drive are in “Fair” condition.

Stream Buffers: There is no stream buffer on the right descending bank as the channel is close to Mission Drive. The stream buffer on the left descending bank is “Excellent” at greater than 15 feet wide from High Drive to midway along the reach, then it is “Good” at 5 to 15 feet wide the remainder of the reach. The stream buffer generally consists of large trees and smaller understory trees and landscaping. The stream buffer generally consists of large trees and smaller understory trees and landscaping.

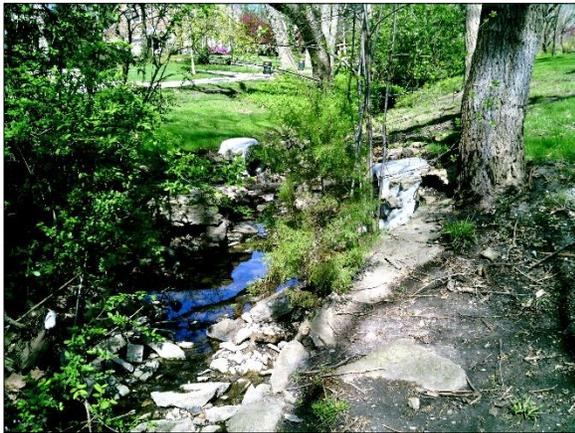
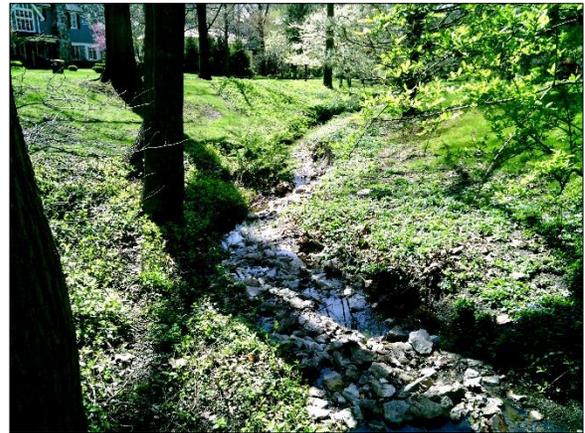
Retaining Walls: There is 447 feet of retaining wall on the left descending bank and 417 feet on the right descending bank. There is 257 feet of retaining wall on the left descending bank and 252 feet on the right descending bank in “Poor” condition. There is 190 feet of retaining wall on the left descending bank and 165 feet on the right descending bank in “Fair” condition.

Stream Buffers: The stream buffer on both banks is in Acceptable condition generally consisting of large trees with turf grass and landscaping ground cover.

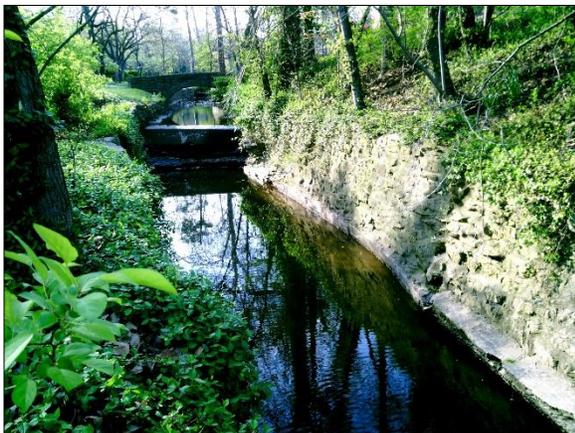
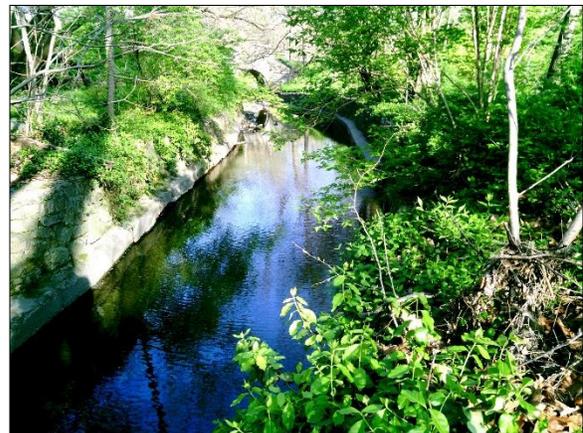
Retaining Walls: There is 955 feet of retaining wall on the left descending bank and 439 feet on the right descending bank. All the retaining walls on the left descending bank are in “Fair” condition, except for a 58-foot section in “Poor” condition near the confluence with Brush Creek. The retaining walls on the right descending bank are in “Fair” condition.

Stream Buffers: There is no stream buffer on either bank for approximately 270 feet downstream of the culvert under the intersection of Ensley Lane and Mission Drive. The stream buffer on the left descending bank then is “Excellent” and changes to “Good” approaching Brush Creek. The stream buffer on the right descending bank is “Good” for the remainder of the reach. The stream buffer generally consists of large trees and smaller understory trees and landscaping.

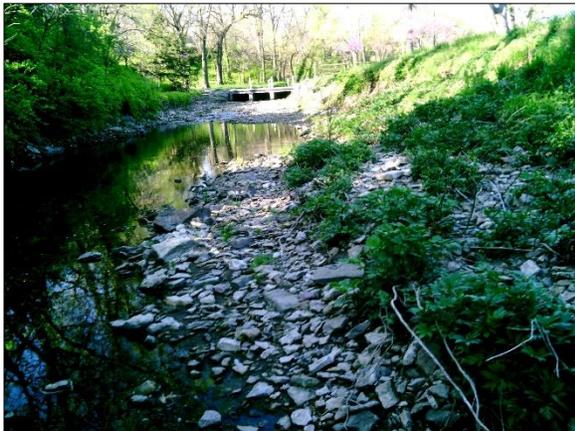
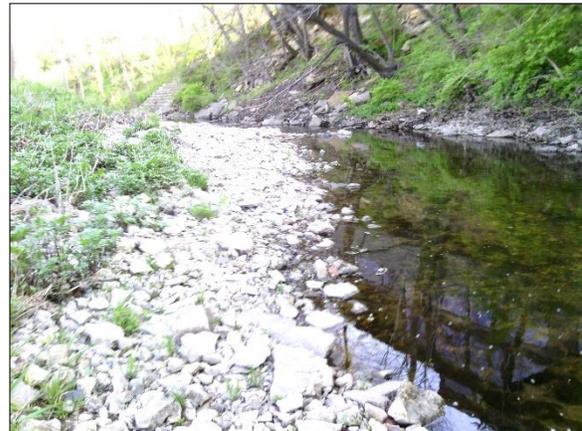
Retaining Walls: There is 418 feet of retaining walls on the left descending bank and 586 feet on the right descending bank. The retaining walls on both banks at beginning of the reach are in “Good” condition. All the other retaining walls are in “Fair” condition.

Stream Buffers: There is no stream buffer on the left descending bank along the golf course. The stream buffer on the right descending bank is “Good” at the beginning of the reach and goes to “Acceptable” and then “None” near Brookbank Lane. The stream buffer generally consists of large trees and smaller understory trees and landscaping.

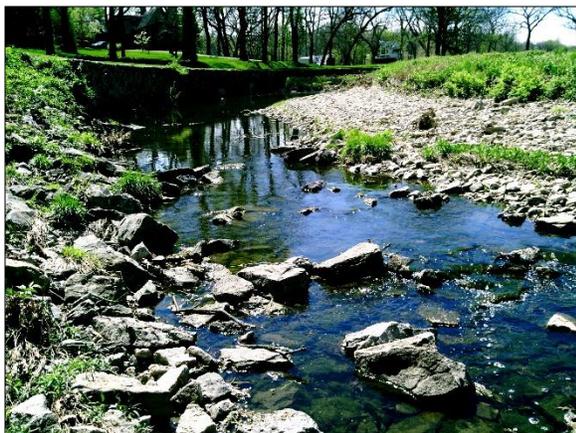
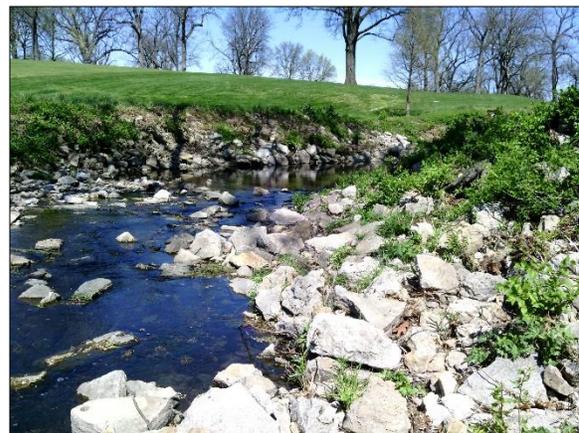
Channel Condition Ranking: Fair

Channel Condition Description: This reach received “Poor” ratings for having steep bank slopes and a lack of woody vegetation on the banks, a lack of sinuosity. This reach received “Good” ratings for having a radius of curvature to channel width ratio between 3 and 5, showing little signs of bank cutting and mass wasting, having small amounts of debris in the channel and a few small obstructions in the channel.

Retaining Walls: There is 299 feet of retaining walls on the left descending bank and 651 feet on the right descending bank. The retaining walls on both banks in “Fair” condition.

Stream Buffers: There is no stream buffer on the right descending bank along Brookbank Lane and Belinder Avenue. There is no stream buffer on the left descending bank along the golf course to the end of Brookbank Lane. The stream buffer on the left descending bank is “Good” for the remainder of the reach. The stream buffer generally consists of large trees and smaller understory trees and unmown turf grass along the golf course.

Localized Improvements: The localized improvements for this reach include repairing/replacing the sections of retaining walls in “Fair” and “Poor” condition along the reach. Site restoration includes Streambank Planting and Sodding. Streambank Planting includes planting native vegetation along the stream bank above the repaired/replaced retaining walls to restore/improve the stream buffer where space is allowed. Sodding includes restoring all other areas disturbed by construction activity.

An estimated 478 feet of retaining wall will need to be replaced along this reach and 532 square yards of sodding.

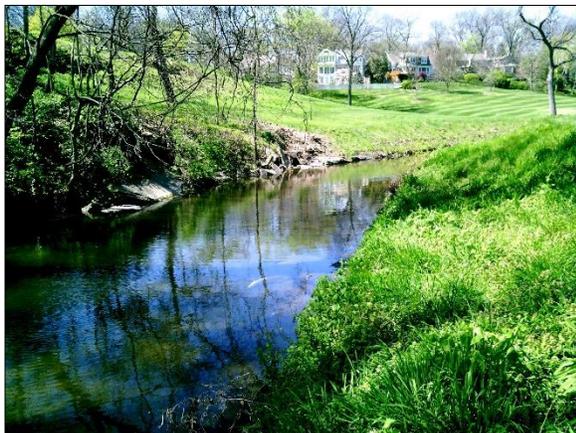
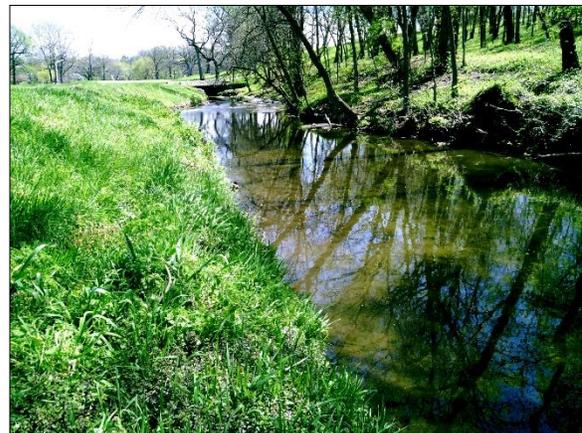
Channel Condition Ranking: Fair

Channel Condition Description: This reach received “Poor” ratings for having a lack of woody vegetation on the banks. This reach received “Good” ratings for having a radius of curvature to channel width ratio between 3 and 5, showing little signs mass wasting, having narrow bar development, having small amounts of debris in the channel and a few small obstructions in the channel. Many stability indicators from the Channel Condition Scoring Matrix were given a “Fair” rating. The end of this reach was included in the Belinder Low-Water Crossing Project (2014).

Retaining Walls: There is 1,149 feet of retaining walls on the left descending bank and 568 feet on the right descending bank. There is 181 feet of retaining wall on the left descending bank in “Good” condition, and the rest of the retaining walls on both banks are in “Fair” condition.

Stream Buffers: There is no stream buffer on the left descending bank for a majority of the reach. There is approximately 520-foot section of “Good” stream buffer midway along the reach. There is no stream buffer on the right descending bank for a majority of the reach with the exception of two areas of “Good” stream buffer and one area of “Excellent” stream buffer. The stream buffer generally consists of large trees with small understory trees and unmown turf grass through the golf course.

Localized Improvements: The localized improvements for this reach include repairing/replacing the sections of retaining walls in “Fair” and “Poor” condition along the reach. Site restoration includes Streambank Planting and Sodding. Streambank Planting includes planting native vegetation along the stream bank above the repaired/replaced retaining walls to restore/improve the stream buffer where space is allowed. Sodding includes restoring all other areas disturbed by construction activity. Streambank reshaping is also included.

An estimated 800 feet of retaining wall will need to be replaced along this reach and 893 square yards of sodding associated with the retaining wall. Approximately 850 feet of streambank will need to be regraded and restored.

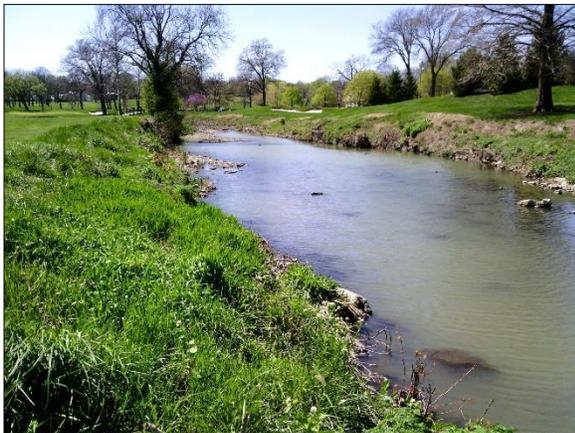
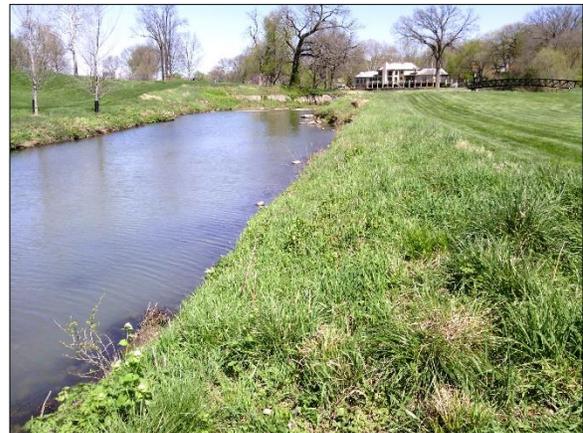
Channel Condition Ranking: Fair

Channel Condition Description: This reach received “Poor” ratings for having a lack of woody vegetation on the banks. This reach received “Good” ratings for having a radius of curvature to channel width ratio between 3 and 5, showing little signs of bank cutting and mass wasting, having small amounts of debris in the channel, and a few small obstructions in the channel. This reach was part of the Brush Creek, Belinder Avenue to East Mission Drive Project (2017).

Retaining Walls: There is 415 feet of retaining walls on the left descending bank and 131 feet on the right descending bank. The retaining walls on the left descending bank is in “Fair” condition. The retaining wall on the right descending bank is in “Poor” condition.

Stream Buffers: The stream buffer on the left descending bank is “Good” for the entire reach. The stream buffer on the right descending bank is “Good” for a majority of the reach, except for the last 100 feet where it is “Acceptable”. The stream buffer generally consists of large trees and smaller understory trees and unmown turf grass along the golf course.

Localized Improvements: The localized improvements for this reach include repairing/replacing the sections of retaining walls in “Fair” and “Poor” condition along the reach. Site restoration includes Streambank Planting and Sodding. Streambank Planting includes planting native vegetation along the stream bank above the repaired/replaced retaining walls to restore/improve the stream buffer where space is allowed. Sodding includes restoring all other areas disturbed by construction activity. Streambank reshaping is also included. Other improvements include bank reshaping and constructing a drop structure,

An estimated 337 feet of retaining wall will need to be replaced along this reach and 375 square yards of sodding associated with the retaining wall. Approximately 340 feet of streambank will need to be regraded and restored.

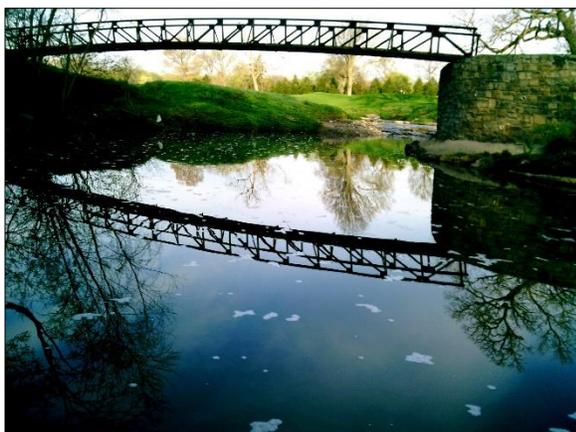
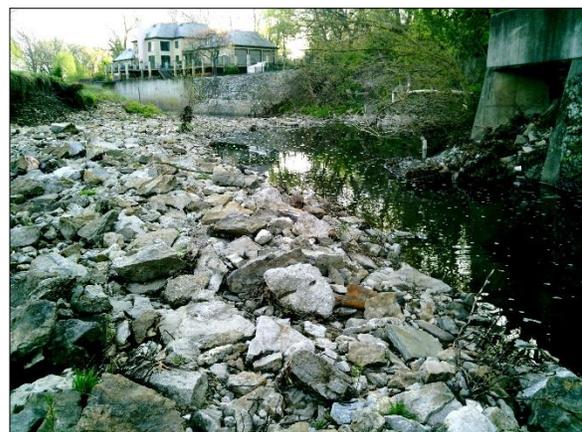
Channel Condition Ranking: Poor

Channel Condition Description: This reach received “Poor” ratings for having steep bank slopes, a lack of woody vegetation on the banks, frequent bank cutting and mass wasting, and bar widths greater than ½ the stream width. This reach received “Good” ratings for having small amounts of debris in the channel and a few small obstructions in the channel. This reach was part of the Brush Creek, Belinder Avenue to East Mission Drive Project (2017) and also the Brush Creek Ramp Project (2013).

Retaining Walls: There is 348 feet of retaining walls on the left descending bank and 475 feet on the right descending bank. The retaining walls on the left descending bank is in “Fair” condition, except for a 46-foot section in “Poor” condition. The retaining walls on the right descending bank are in “Fair” condition except a 78-foot section in “Good” condition which was replaced as part of the Brush Creek Ramp Project (2013).

Stream Buffers: The stream buffer on the left descending bank is “Good” for the entire reach. The stream buffer on the right descending bank is “Acceptable” for the first 444 feet, and there is no stream buffer for the remainder of the reach. The stream buffer generally consists of large trees and smaller understory trees and unmown turf grass along the golf course.

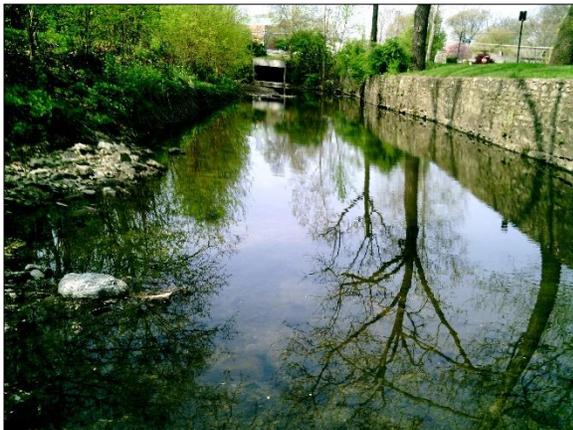
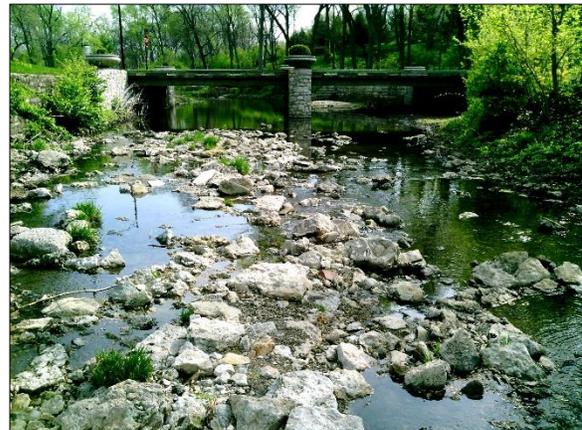
Retaining Walls: There are a total of 412 feet of retaining wall on the left descending bank and 346 feet of retaining wall on the right descending bank. A 142-foot section of gabion retaining wall on the left descending bank and a 316-foot section of concrete retaining wall on the right descending bank are in “Fair” condition. A 248-foot section on the left descending bank is in “Poor” condition. The remaining retaining walls are in “Good” condition.

Stream Buffers: The stream buffer condition ranges from “Good” at 5 to 15 feet wide to “Acceptable” at 1 to 5 feet wide on the left descending bank behind the church parking lot. There is no stream buffer on the left descending bank along W. 66th Street. The stream buffer on the right descending bank ranges from “Excellent” at greater than 15 feet wide to “Good” along the church parking lot and part of W. 66th Street. There is no stream buffer on the right descending bank approaching the Indian Lane culvert. The stream buffer generally consists of large trees and smaller understory trees.

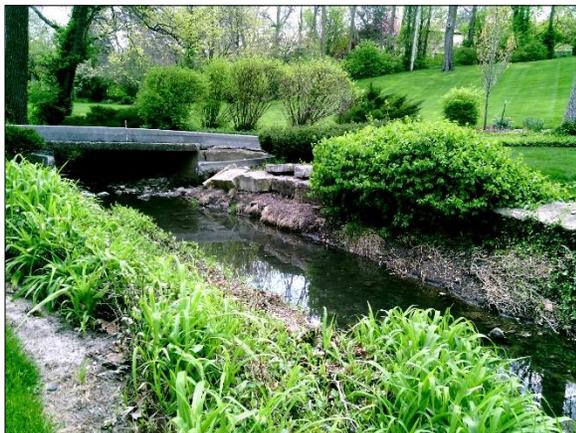
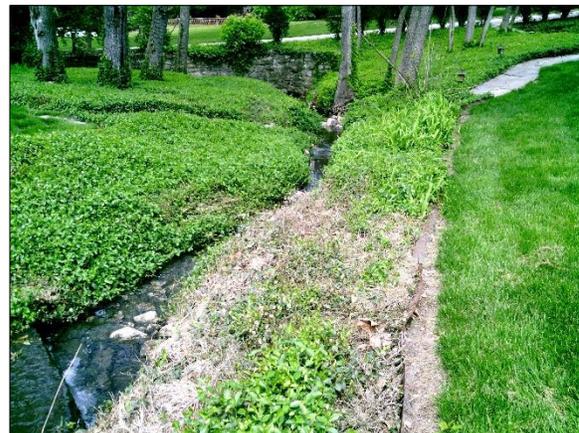
Retaining Walls: There is 186 feet of retaining wall on the left descending bank and 173 feet on the right descending bank. The retaining walls on both banks are in “Good” condition.

Stream Buffers: There is no stream buffer on either bank for a majority of the reach, except for one location on each bank where the stream buffer is “Acceptable”. The stream buffer generally consists of large trees and landscaping.

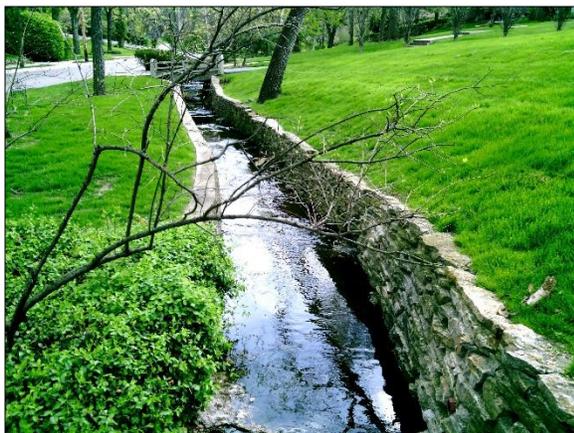
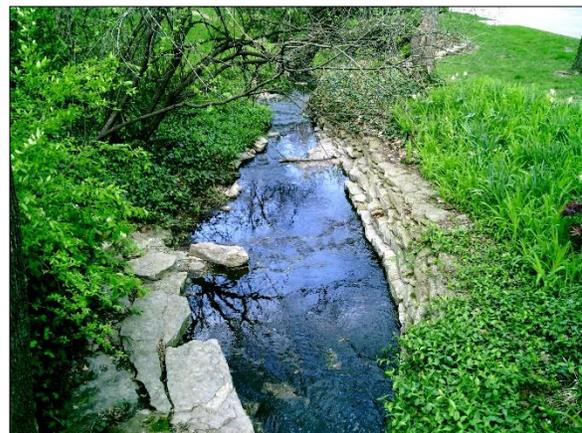
Retaining Walls: There is 95 feet of retaining wall on the left descending bank and 132 feet on the right descending bank. The retaining wall on the left descending bank is in “Poor” condition. 96 feet of retaining wall on the right descending bank is in “Poor” condition, and the remaining wall on the right descending bank is in “Fair” condition.

Stream Buffers: There is no stream buffer on either bank for the first half of the reach and “Acceptable” for the second half of the reach. The stream buffer generally consists of large trees and landscaping.

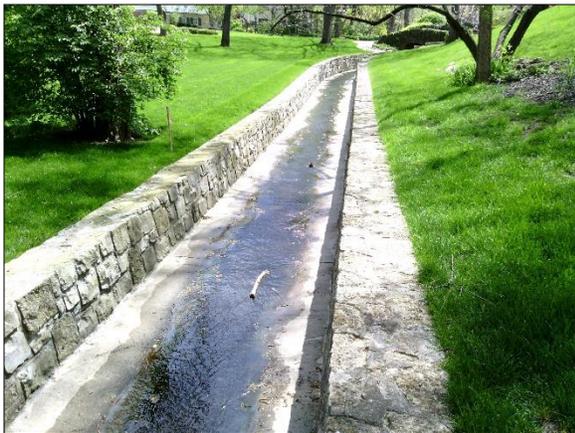
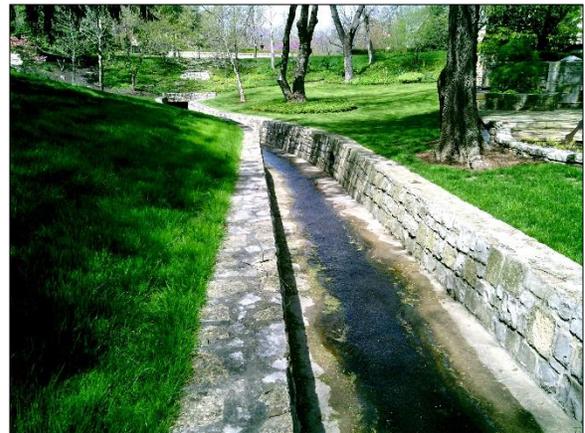
Retaining Walls: There is 908 feet of retaining wall on the left descending bank and 894 feet on the right descending bank. The retaining walls on both banks are in "Fair" condition.

Stream Buffers: There is no stream buffer on either bank for a majority of the reach. The stream buffer is "Good" approaching the confluence with Brush Creek. The stream buffer generally consists of large trees and landscaping.

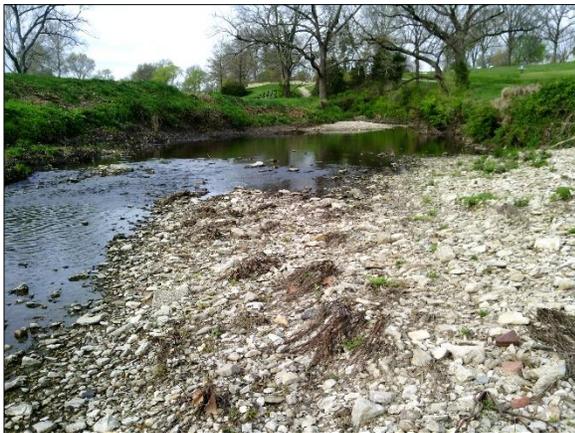
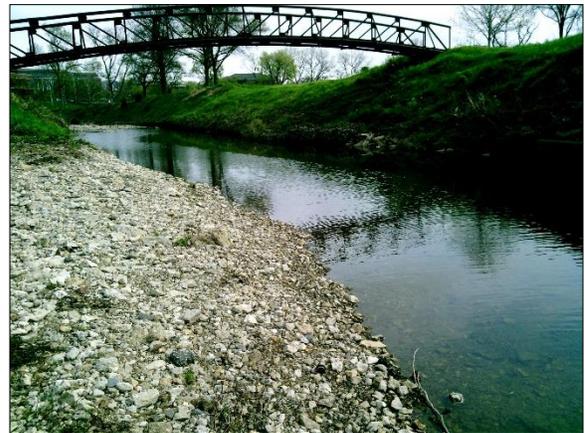
Retaining Walls: There is 243 feet of retaining walls on the left descending bank and 317 feet on the right descending bank. 288 feet of the retaining wall on the right descending bank is gabion wall. The retaining wall on the left descending bank is in “Poor” condition. The retaining walls on the right descending bank are in “Fair” condition.

Stream Buffers: There is no stream buffer on either bank along this reach.

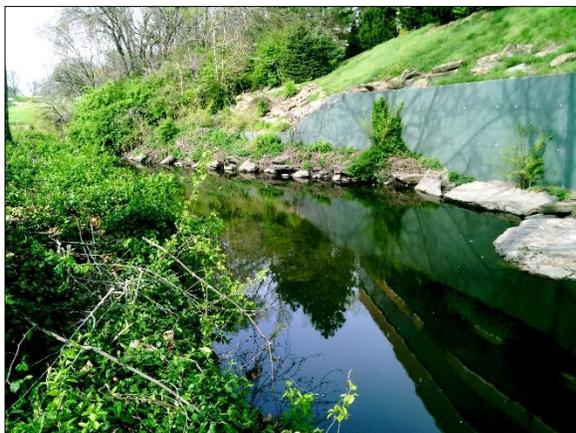
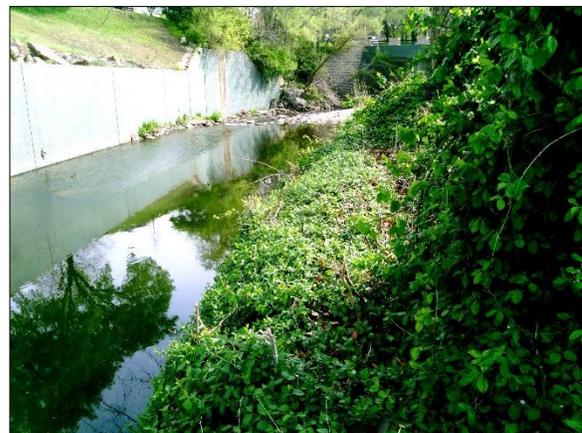
Retaining Walls: There is 322 feet of retaining walls on the left descending bank and 345 feet on the right descending bank. 178 feet of the right descending bank retaining wall is gabion wall. The retaining walls on both banks are in “Fair” condition.

Stream Buffers: There is no stream buffer for a majority of the reach on the left descending bank before changing to “Good” just upstream of State Line Road. There is no stream buffer on the right descending bank for the first half of the reach. The stream buffer on the right descending bank is “Acceptable” for the second half of the reach. The stream buffer generally consists of large trees with small understory trees and unmown turf grass through the golf course.

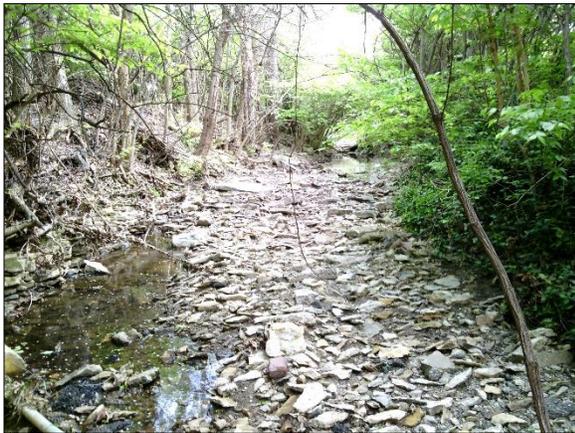
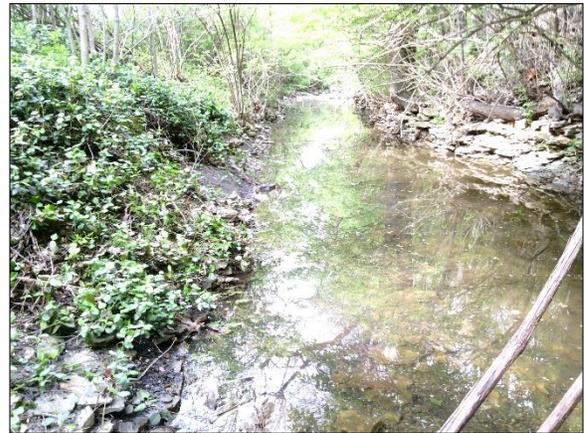
Reach 37 – Existing Conditions

Channel Condition Score: 21.8

Channel Condition Ranking: Poor

Channel Condition Description: This reach received “Poor” ratings for having bank angles greater than 60 degrees, frequent evidence of mass wasting, a lack of sinuosity, and a large radius of curvature to channel width ratio. This reach received “Good” ratings for having cohesive bank materials and small amounts of debris in the channel. Many of the Channel Condition Scoring Matrix stream stability indicators were given a “Fair” rating.

Retaining Walls: There are no retaining wall along this reach.

Stream Buffers: The stream buffer condition is “Good” at 5 to 15 feet wide on both banks. The stream buffer generally consists of large trees and smaller understory trees.

Optimal restoration:

- Match proposed cross-section (see sketch below).
- Add meandering pattern to channel.
- Vegetate banks and create buffer zone.
