**2017 Mission Hills Open Channel
Masterplan Update
Final Report**
Prepared for the City of Mission Hills, Kansas
October 20, 2017

Subject: Mission Hills 2017 Open Channel Masterplan Update

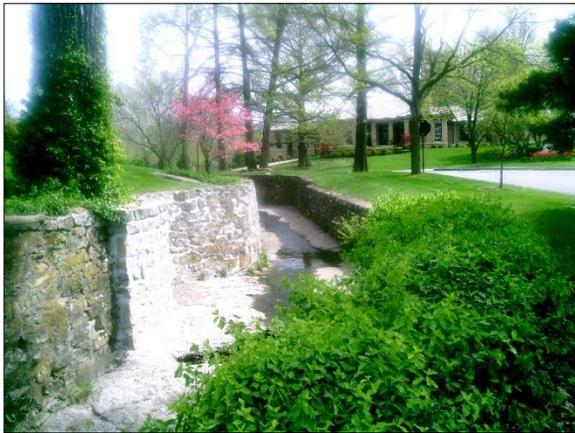
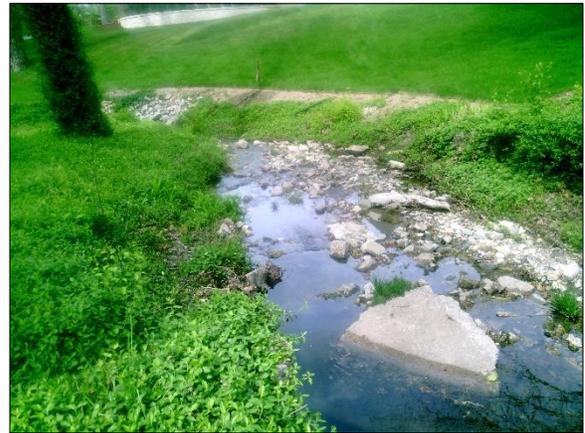
Reach 38 – Existing Conditions

Channel Condition Score: 19.4

Channel Condition Ranking: Fair

Channel Condition Description: This reach received “Poor” ratings for having bank angles greater than 60 degrees, lack of woody vegetation, and a large radius of curvature to channel width ratio. This reach received “Good” ratings for having little evidence of bank cutting and mass wasting, narrow bar widths, small amounts of debris in the channel, few obstructions in the channel, and a sinuosity between 1.2 and 1.4.

Retaining Walls: There are a total of 195 feet on the left descending bank and 188 feet of retaining wall on the right descending bank. The retaining walls on both banks are in “Fair” condition.

Stream Buffers: The stream buffer condition is “Good” at 5 to 15 feet wide for most of the left descending bank. There is no stream buffer on the right descending bank. The stream buffer generally consists of large trees and residential landscaping at the top of the retaining walls.

Localized Improvements: The localized improvements for this reach include repairing/replacing the sections of retaining walls in “Fair” condition along the reach. Site restoration includes Streambank Planting and Sodding. Streambank Planting includes planting native vegetation along the stream bank above the repaired/replaced retaining walls to restore/improve the stream buffer where space is allowed. Sodding includes restoring all other areas disturbed by construction activity.

An estimated 192 feet of retaining wall will need to be replaced along this reach and 215 square yards of sodding.

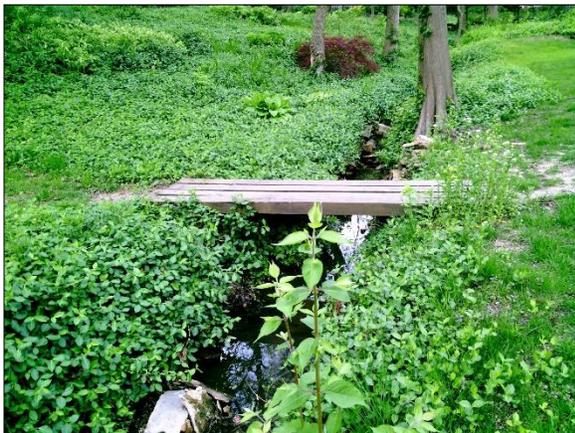
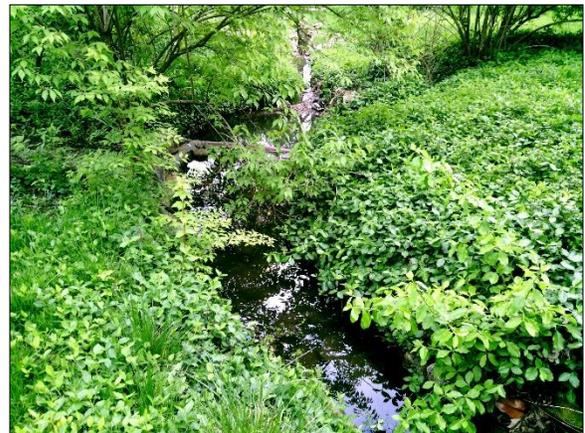
Reach 39 – Existing Conditions

Channel Condition Score: 17.0

Channel Condition Ranking: Fair

Channel Condition Description: This reach received “Poor” ratings for having a lack of sinuosity and a large radius of curvature to channel width ratio. This reach received “Good” ratings for having bank heights less than six feet, little evidence of bank cutting and mass wasting, narrow bar widths, small amounts of debris in the channel, and few obstructions in the channel.

Retaining Walls: There are no retaining walls along this reach.

Stream Buffers: The stream buffer condition ranged from “None” to “Excellent” on both bank of this reach. The stream buffer generally consists of large trees and residential landscaping.

- Match proposed cross-section.
- Add meander pattern to channel.
- Vegetate banks and create buffer zone.

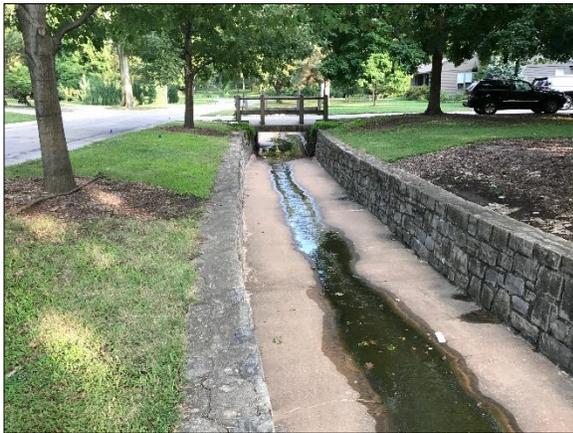
Reach 40 – Existing Conditions

Channel Condition Score: 19.0

Channel Condition Ranking: Fair

Retaining Walls: There are a total of 568 feet of retaining wall on the left descending bank and 556 feet of retaining wall on the right descending bank. The retaining walls on both banks are in "Good" condition.

Stream Buffers: There is no stream buffer along this reach.

- Remove walls and reduce side slopes to 2:1. Add wall were necessary for bank stability.
- Match proposed cross section and add meandering patter to main channel. Create flood benches.
- Replace two driveway culverts to accommodate new channel.
- Vegetate banks and create buffer zone.
